# The 2003 Tokachi-oki Earthquake of September 26

## 1. Summary

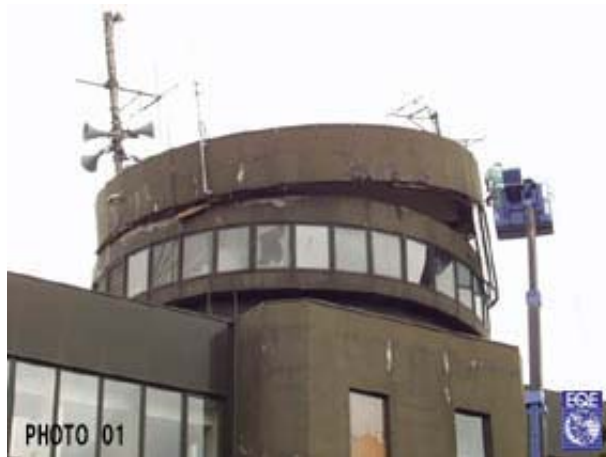
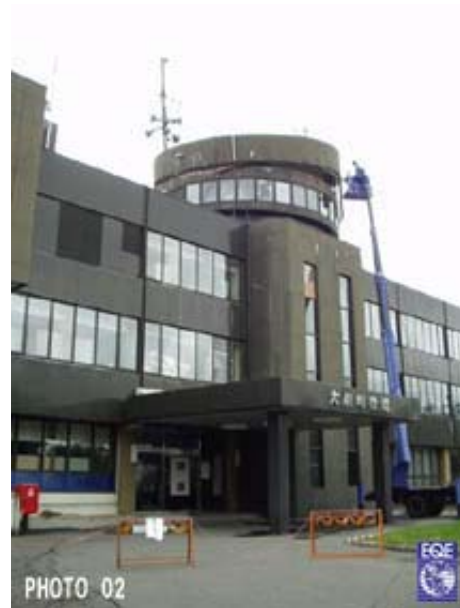
The Taiki-cho Town Hall is a 3-story steel frame structure, and has a 2-story observation penthouse on the top of the building (PHOTO 01 and PHOTO 02). Although the roof of the penthouse appears to be very heavy due to the weight of the parapet with perfect waterproofing, it is only marginally supported by four columns. The strength of the columns appears to be insufficient to support such a heavy roof against strong shaking.

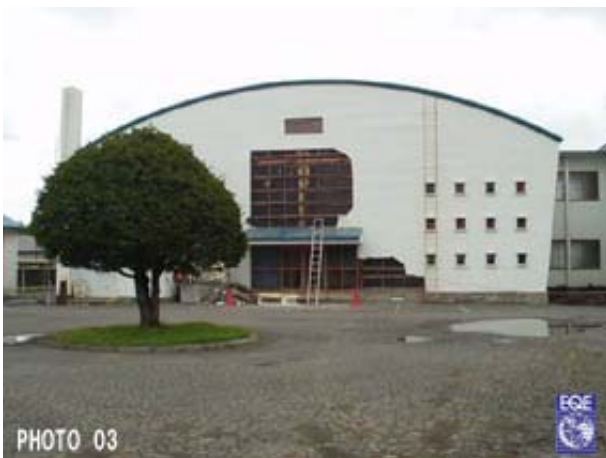
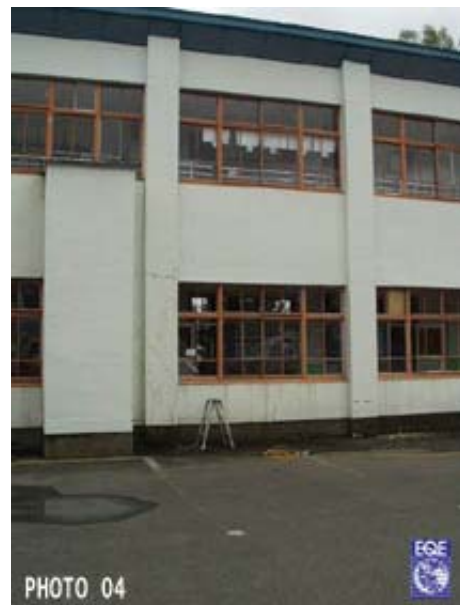
The school is located near the town hall described above. Much damage was observed the exterior walls, windows and columns of the gym (PHOTO 03) and school building (PHOTO 04). The school had been assigned as an evacuation center. Further considerations would be necessary if people had to evacuate to such a highly vulnerable or damaged building.

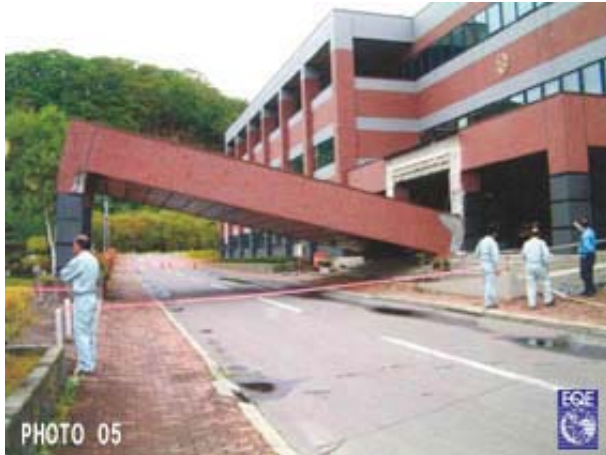
The Kushiro Town Hall was recently built. There was localized damage at the appentice for the entrance. It had been entirely removed already, when the team arrived there. (PHOTO 05, The photo is provided photo by the Kushiro Town Office)

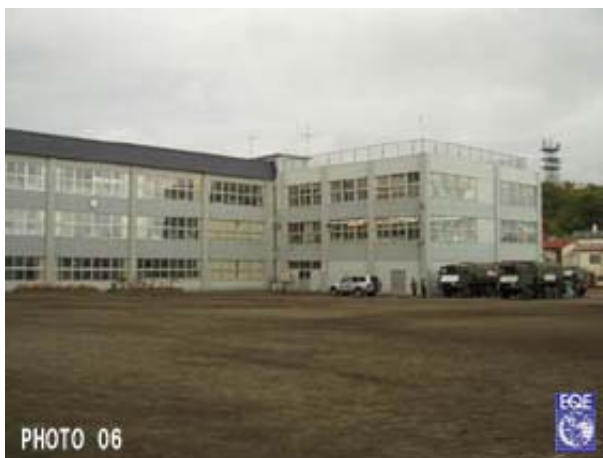
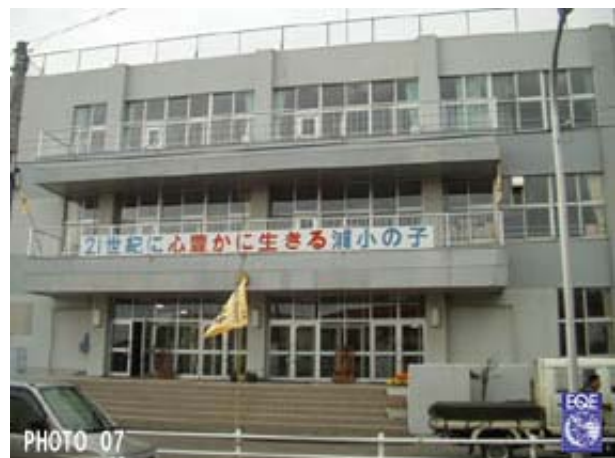
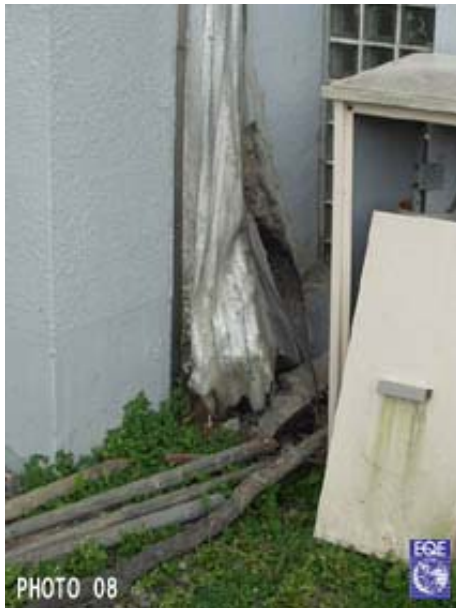
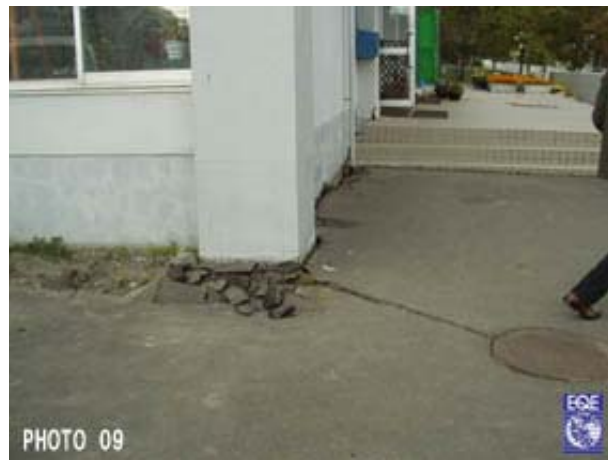
The Urakawa elementary school is a 3-story RC structure, and has an "L"-shaped plan (PHOTO 06). The expansion joints between the entrance building (PHOTO 07) and classroom building (PHOTO 08), and the column foundation of the entrance building (PHOTO 09) were damaged. Reportedly, the school lessons would begin on Monday 29 in the classroom without damage.

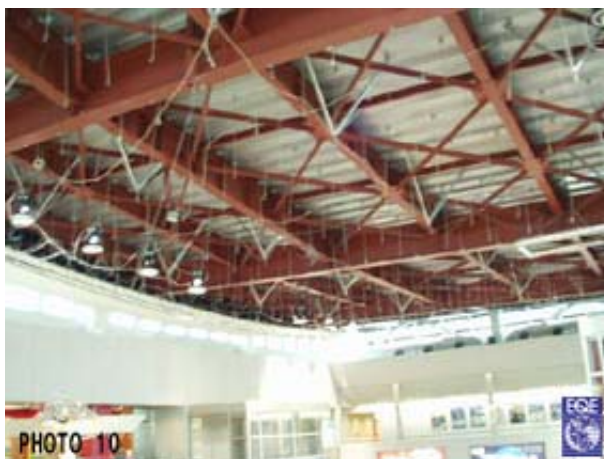
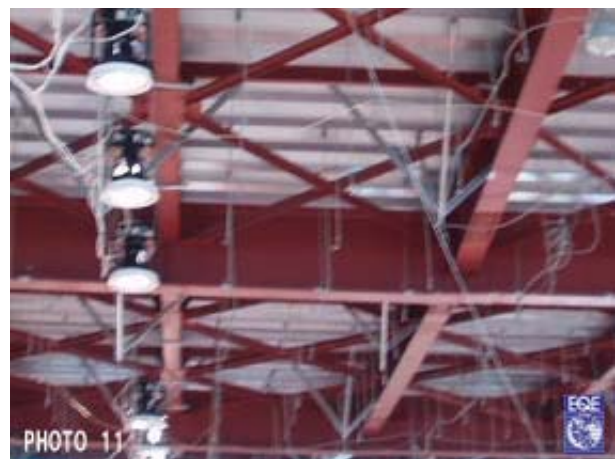
The ceiling of the Departure Lobby in the Kushiro Airport fell down (PHOTO 10 and PHOTO 11). The operations of the Kushiro Airport were interrupted almost for a day due to the restoration. The repair work was completed at 4:55 pm on Sep. 26, and the airport was reopened at that time. Thirty-two flights out of the 36 regular flights had been cancelled as a result.

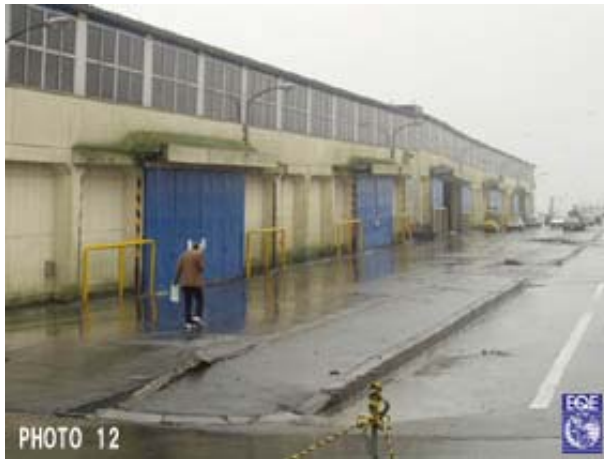
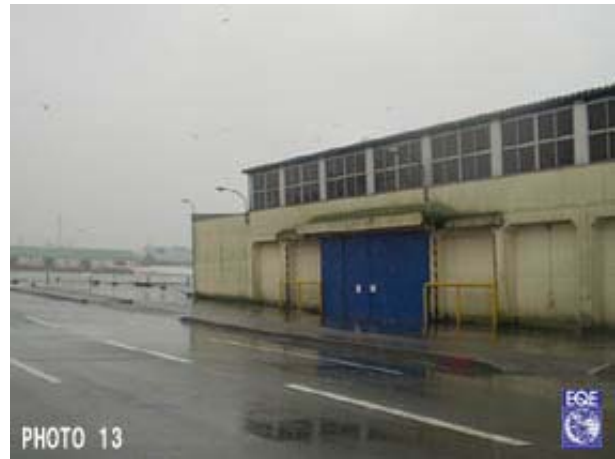
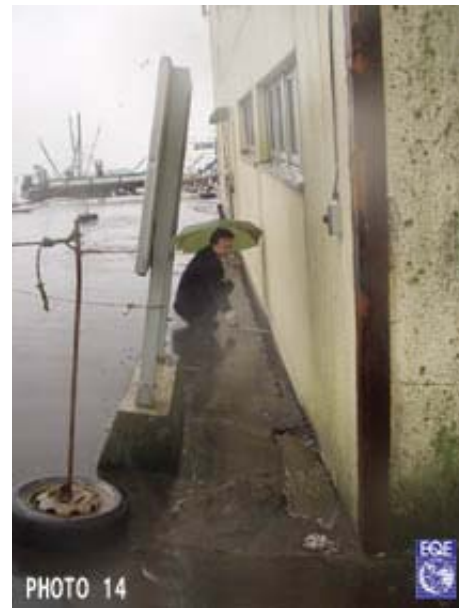
Liquefaction was observed in the Kushiro Fishing Port. There is a building that is separated by expansion joints into two structures (PHOTO 12 and PHOTO 13). One of the two structures settled down about 45cm at maximum due to liquefaction (PHOTO 14). When we arrived there, the building was being used as usual, even though it was damaged.

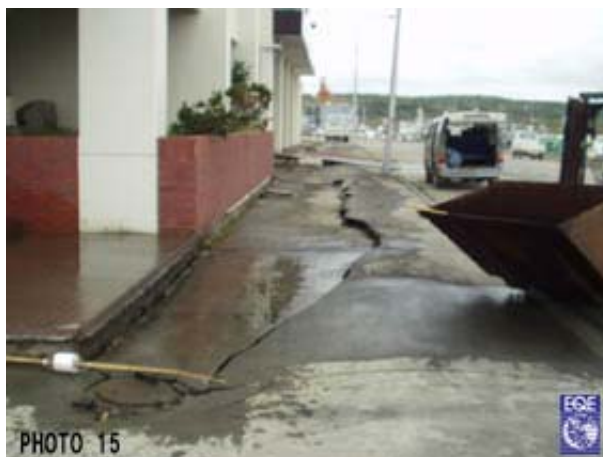
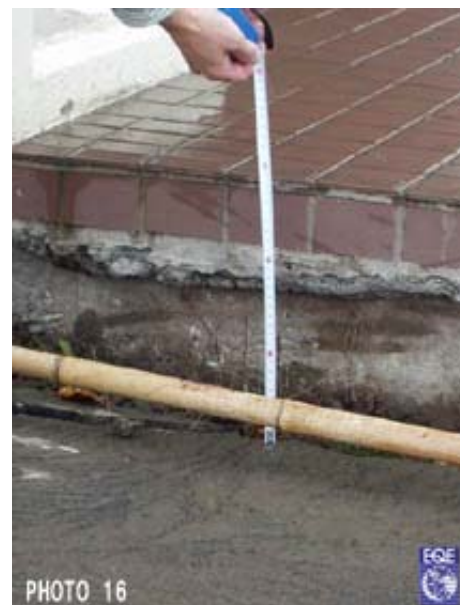
The ground around a building in the Otsu Fishing Port settled down about 30cm due to liquefaction. We observed evidence that this building was inundated with Tsunami waves (PHOTO 15 and PHOTO 16).

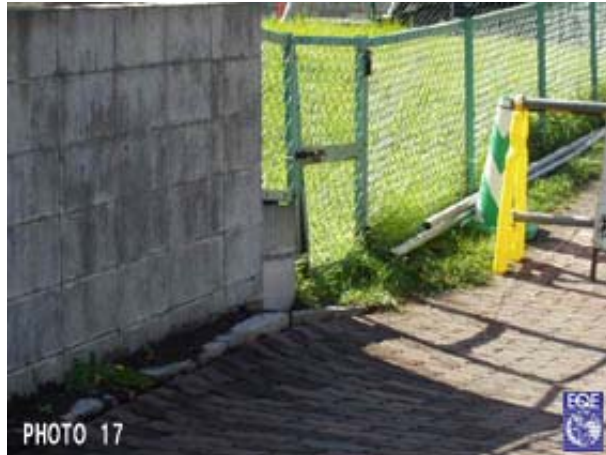
Ground settlement (30-40cm) due to liquefaction was observed on the road in Utsukushigaoka, which continues over 30 to 40m. More than 5 houses had been tilted due to the differential settlement (PHOTO 17).

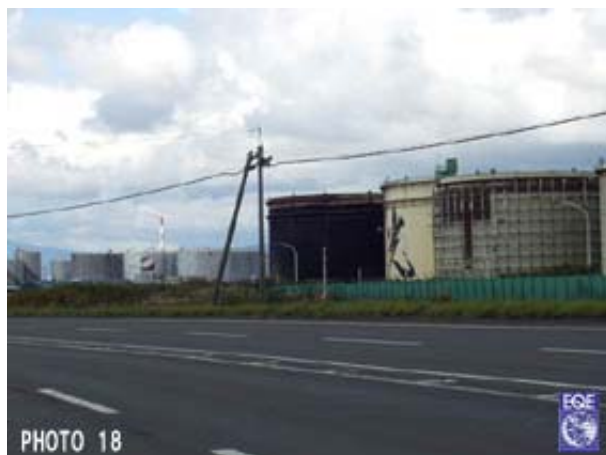
At 4:52 am on Sep. 26, fire following the earthquake burned down a crude oil tank (32,778kl) in the Hokkaido Refinery in Tomakomai (Idemitsu Kosan Co. Ltd.). Simultaneously, oil leaked from the piping in the refinery, and resulted in a fire, which was brought under control at 12:09pm on September 26 (PHOTO 18). The roof type of the tank caused fire is called a "floating roof," whose steel roof is floating on the stored oil in the tank and moves up and down depending on the quantity of the oil. According to the Fire Department, a fire may have initiated due to "sloshing" actions of the floating roof. The roof swung together with the oil in the tank that was shaken by the earthquake ("sloshing"), and then the oil spilled out onto the roof. The fire ignited the oil due to the friction between the roof and sidewall of the tank.

A Naphtha tank (26,000kl) in the same refinery initiated a fire at 10:36 on September 28. The floating roof had been tilted due to sloshing and the oil had spilled on the roof. It is thought that the spilled oil on the roof had caught a fire for some reason.

It is reported that, in the refinery, there were about 90 oil tanks out of which oil spilled onto the floating roof due to "sloshing."

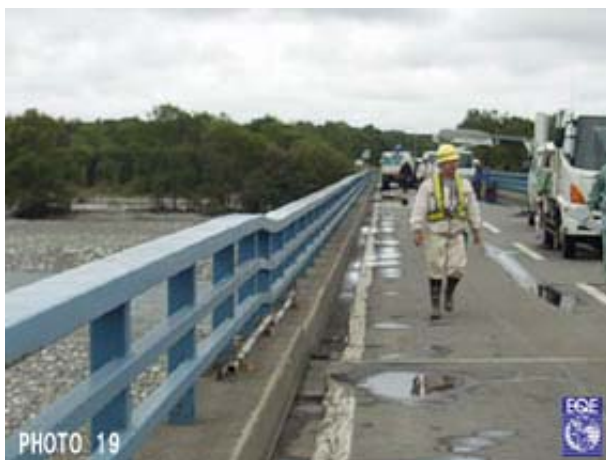
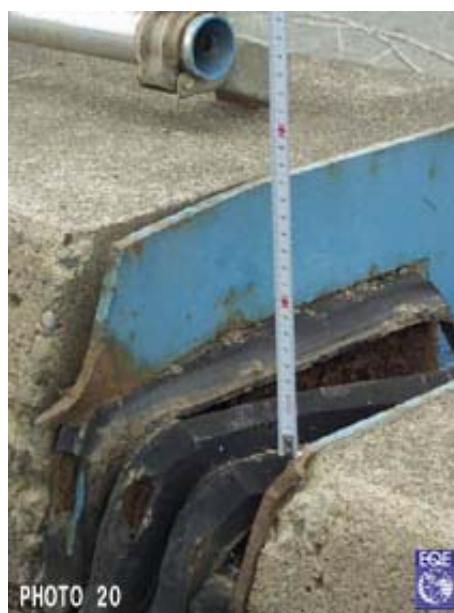
The center of the Rekifune Bridge sagged about 120mm at the joint section, since the ground under the bridge pier was deformed (PHOTO 19 and PHOTO 20).

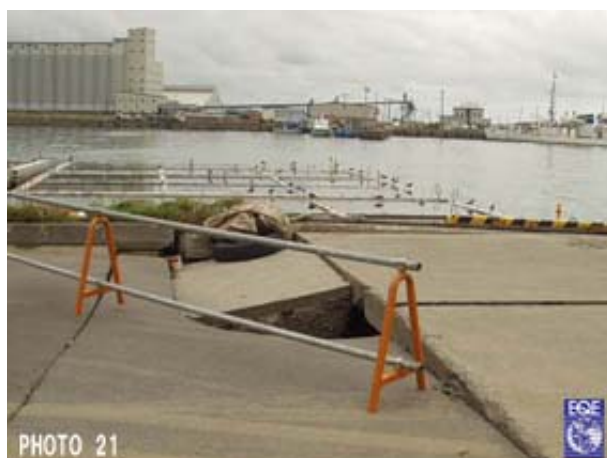
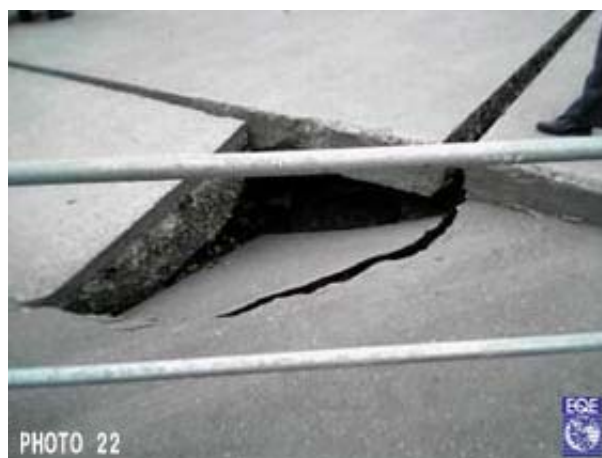
The lateral spreading of the ground soil (15cm in lateral and 15 to 20cm in vertical) caused severe damage such as cracking in the quay walls (PHOTO 21 and PHOTO 22).

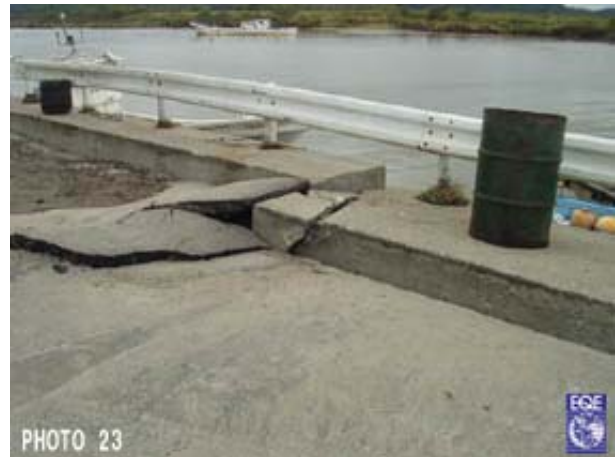
Movement of the quay walls was accompanied by lateral spreading of the ground soil (PHOTO 23). (20cm in lateral and 9-20cm in vertical)

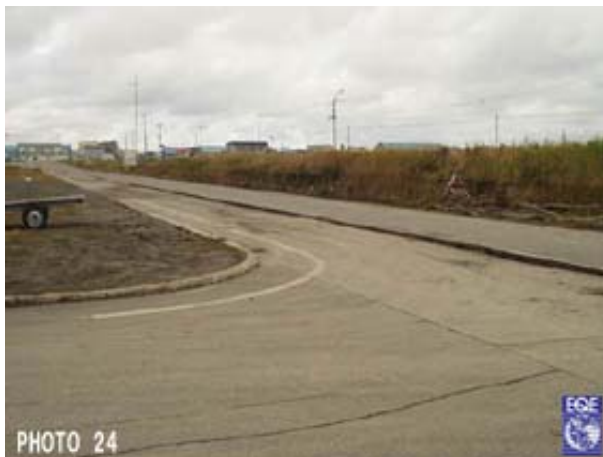
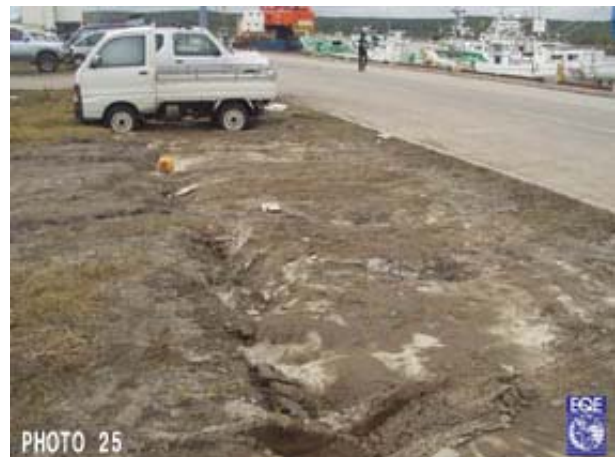
There are many signs of boiling sand, indicating that liquefaction occurred in the port (PHOTO24 and PHOTO25).

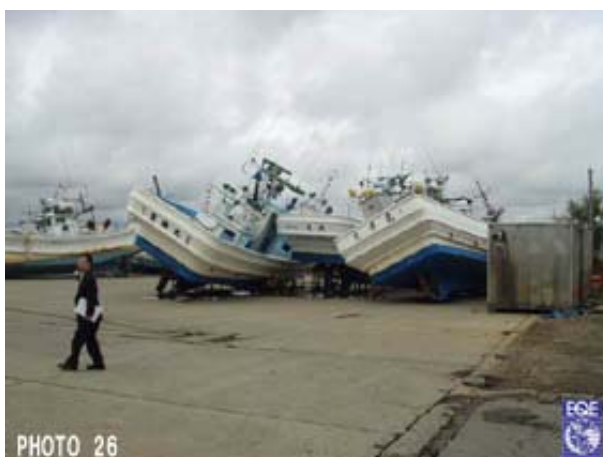
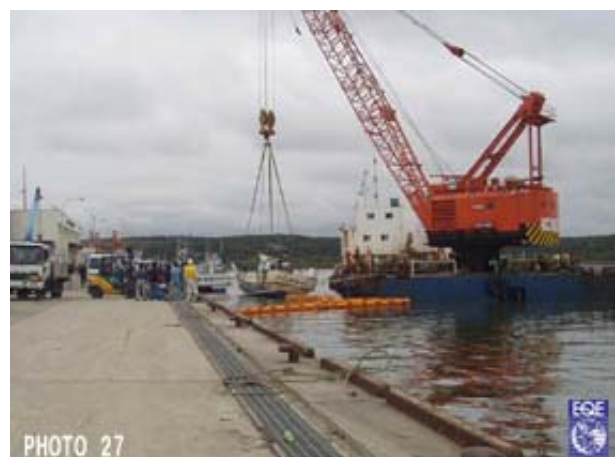
Fishing boats were cast up onto the port by Tsunami (PHOTO 26). A large crane on the barge was hoisting these boat back into the sea (PHOTO 27).

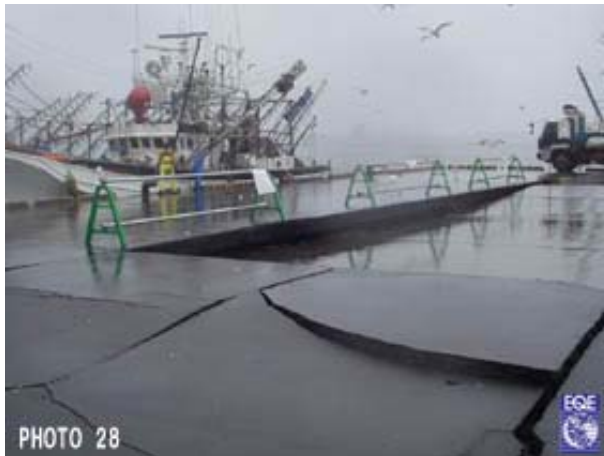
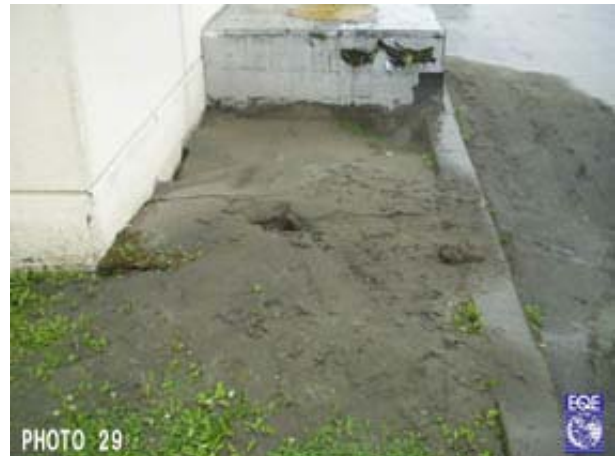
The quay walls moved about 14cm laterally and 23cm in vertically due to liquefaction, and there are many signs of boiling sand in some places (PHOTO 28 and PHOTO 29). Due to the difference in the ground level caused by large-scale ground deformation, fork lifts were not able to be used at the ship-port interface during unloading from the ship. It significantly compromised the workability of the port.

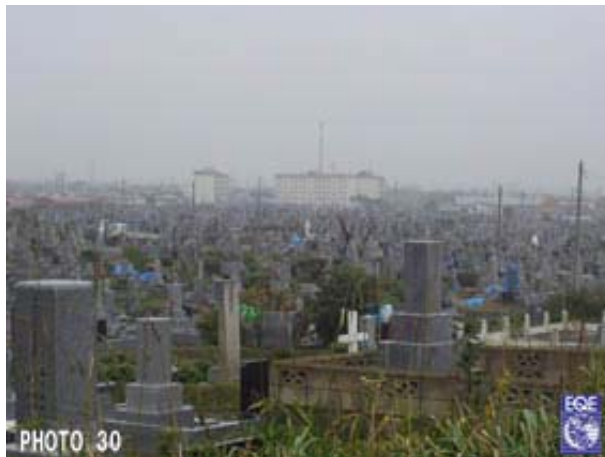
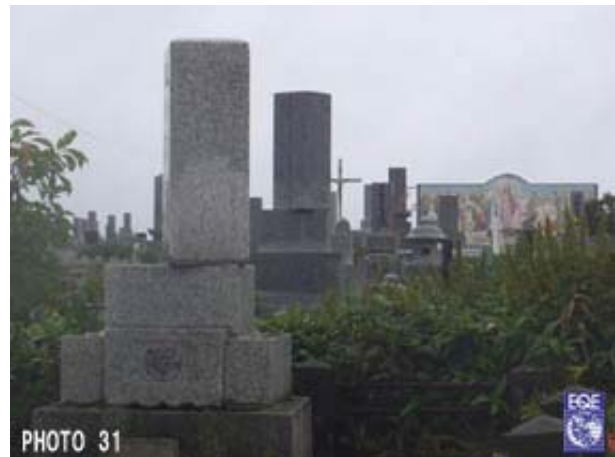
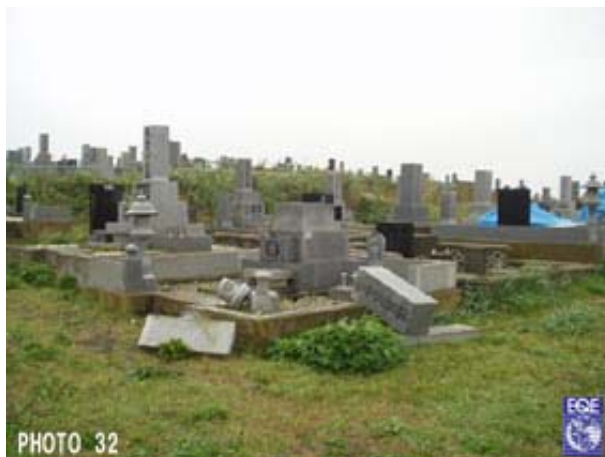
In general, there was no significant damage in the cemetery even where the intensity was 5+, since the gravestones in the surveyed area were anchored with sealing materials. In Shiundai Cemetery, however, there were some overturned or slid gravestones (PHOTO 30, PHOTO 31 and PHOTO 32).

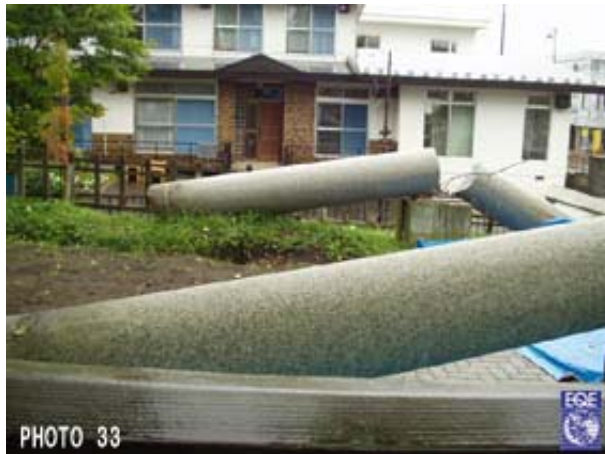
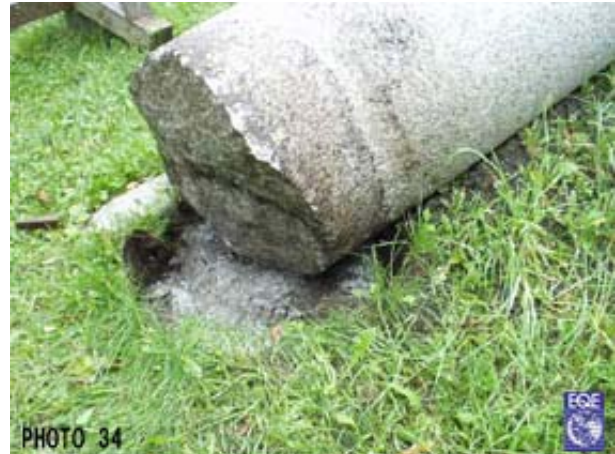
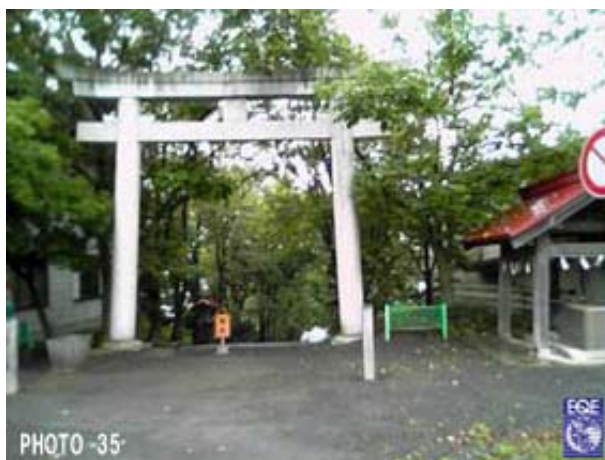
The Itsukushima Shrine is located on the hill. One of the shrine gates at the foot of the hill overturned due to the earthquake shaking (PHOTO 33 and PHOTO 34). There was no damage to the shrine gate on the hill and the houses in the vicinity of the shrine (PHOTO 35).

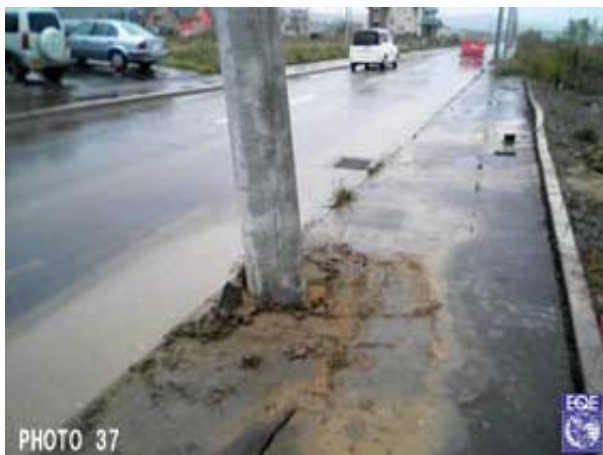
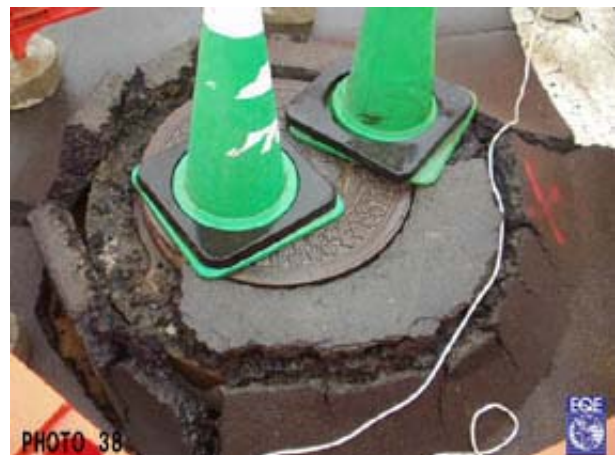
According to the Hokkaido prefecture government, water supply for 14 cities, 32 towns, and 2 villages (16,006 households) was cut off due to the electrical power failure or the pipe damage caused by ground deformation or liquefaction (PHOTO 37). Water contamination was also reported. As of 4:00 pm on the 28th of September, the water of 1640 households was cut off.

In the Shin-Toyo apartment block in Kushiro-cho, the pipes of the underground sewage system were floated up due to liquefaction, and outstanding manholes could be seen on the ground surface in many places (PHOTO 38). According to the Kushiro-cho office, such damage occurred along 80% of the overall piping length of 8km within the Shin-Toyo apartment block.

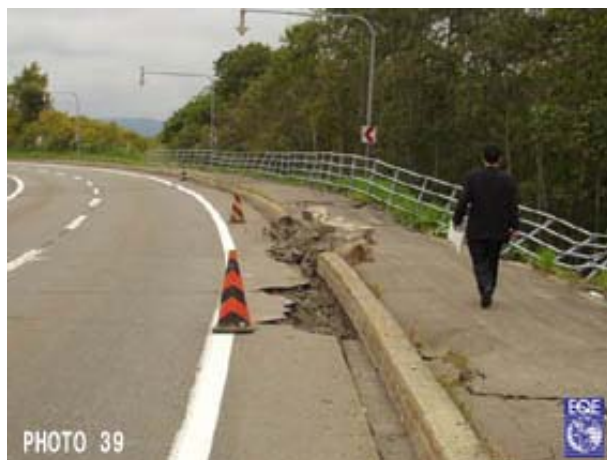
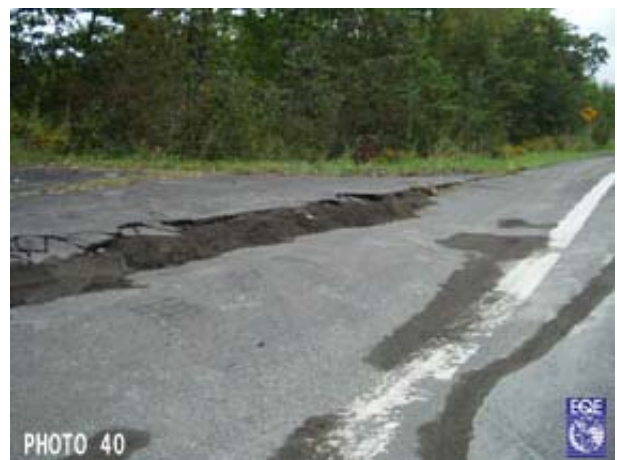
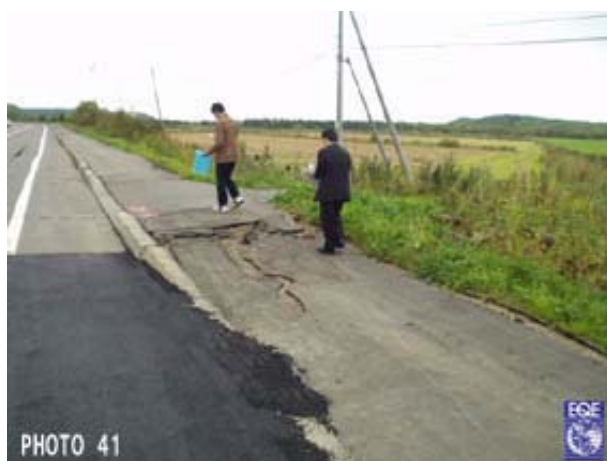
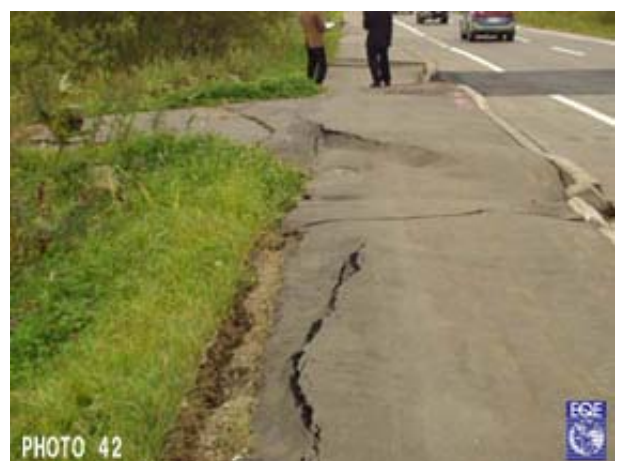
The earthquake caused ground rupture and settlement in the roads as well as the landslides, and traffic was closed or regulated in various regions. In Taiki-cho and Toyokoro-cho, circular slip occurred on Route 336 that runs through the slope, and the road moved 230mm horizontally and 170mm vertically at the location-1 in the figure below (PHOTO 39). Similarly, the slip recorded the horizontal and vertical movements of 700mm and 400mm respectively at the location-2 (PHOTO 40). At the location-3, on the same Route 336, there was ground settlement of 300mm supposedly along the underground wastewater piping (PHOTO 41). Ground settlement was also observed in another road running through the farmland due to the circular slide of the embankment (PHOTO 42).

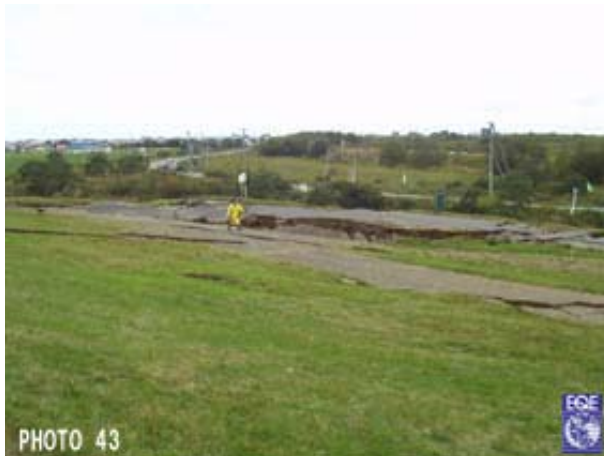
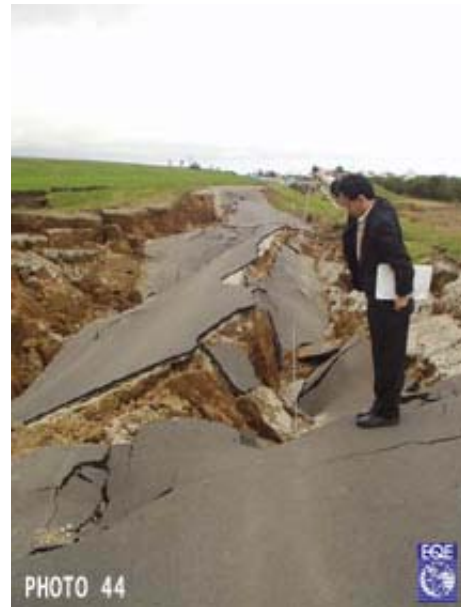
The bank in the mouth of the Tokachi River was severely torn down (PHOTO 43 and PHOTO 44).

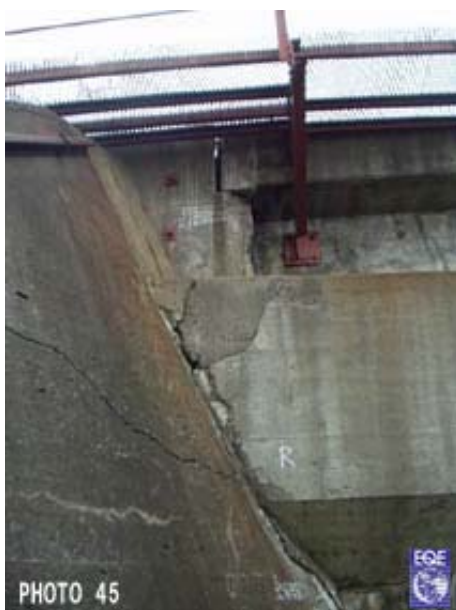
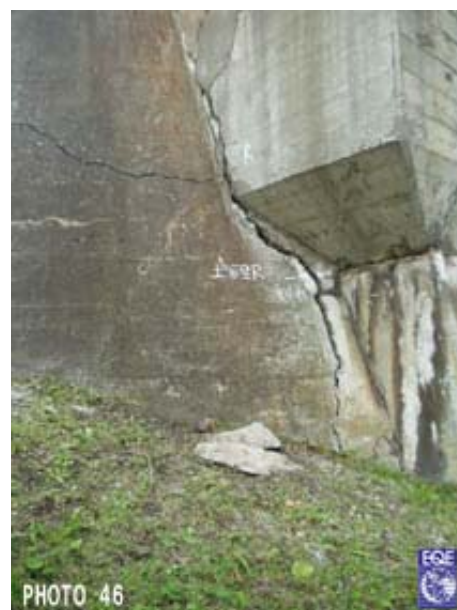
Almost a hundred damaged items (such as caved railways, bent rails and joint ruptures of the bridges) were reported throughout the railroads, and the railroad traffic was interrupted in many areas. The most significant damage was that the Express “Marimo” went off the rails near Naobetsu. There were some cracks caused by the earthquake in the concrete substructure at the railroad bridge near the Urakawa station (PHOTO 45 and PHOTO 46).
