The explosion and fires at the Texaco Refinery, Milford Haven, 24 July 1994

**A report of the investigation by the Health and
Safety Executive into the explosion and fires on
the Pembroke Cracking Company Plant at the
Texaco Refinery, Milford Haven on 24 July 1994**

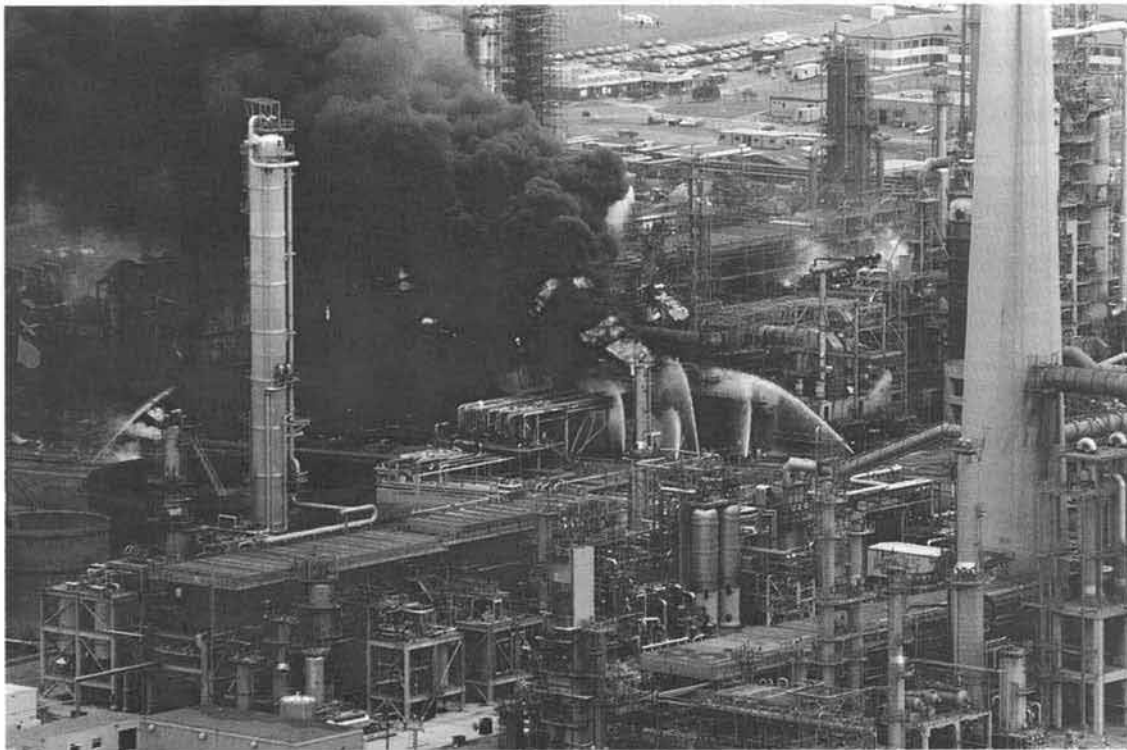
View from south west showing fire at flare drum (photograph courtesy of the Western Mail and Echo Ltd)

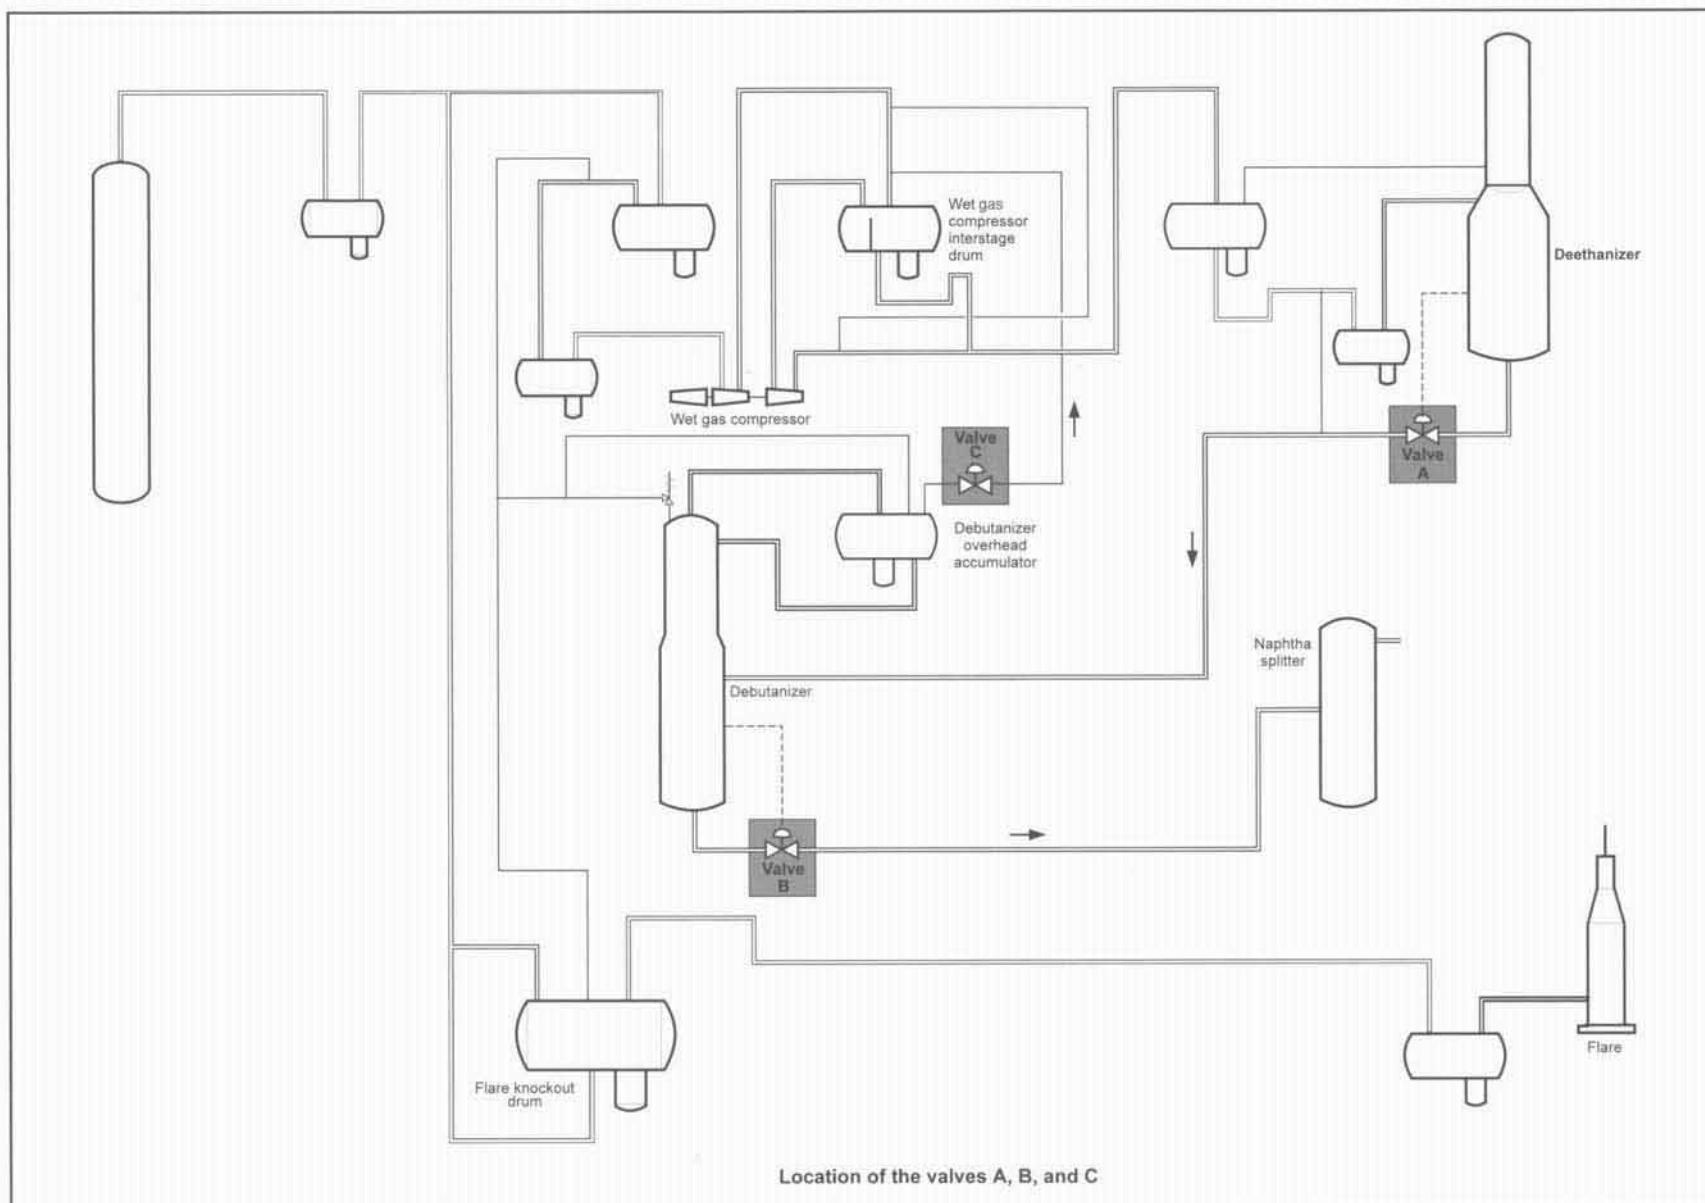
Figure 4 Simplified process diagram, to illustrate the interaction of the key valves and vessels that led to the incident (paragraphs 61 to 70)

- 63 Shortly after 09.00 the liquid level in the deethaniser was restored so **valve A** opened and flow was restored to the debutaniser. This should have caused **valve B** to open and allow hydrocarbon out of the already pressurised debutaniser into the naphtha splitter. However, **valve B** never opened. Operators in the control room received signals wrongly indicating that it had opened and the debutaniser continued to fill with liquid while the naphtha splitter emptied.

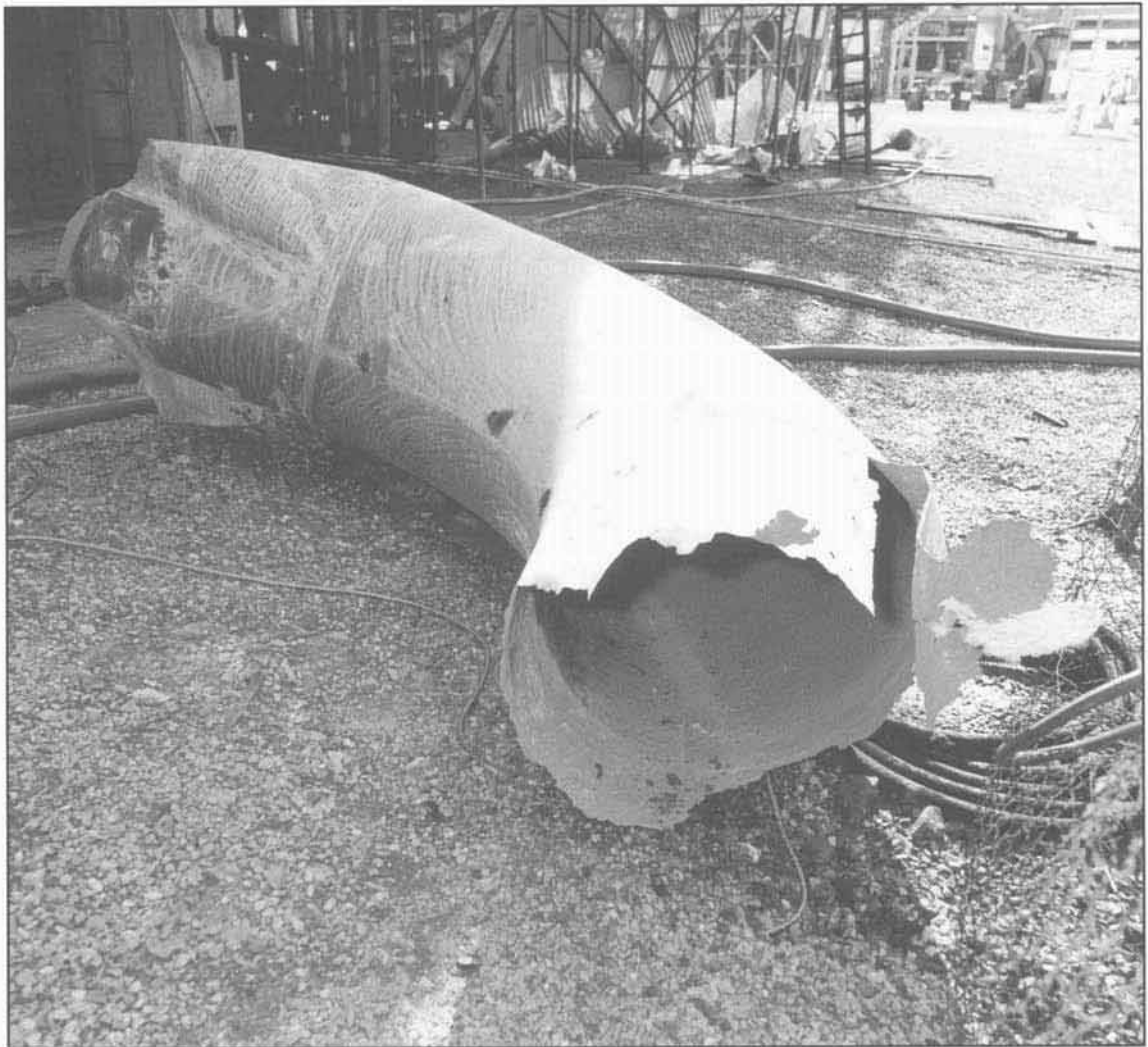
Figure 5 The 30 inch flare line elbow bend that failed and fell to the ground, releasing the hydrocarbon liquid and vapour

The flare drum outlet line which failed, releasing the hydrocarbon that exploded, was severely corroded. The presence of corrosion was known, but the full extent was not recognised because it had not been inspected at the point of failure, where there were inspection access difficulties. Although the flare line was clearly not properly maintained at this point, the investigation subsequently determined that this corrosion was not a direct cause of the incident.

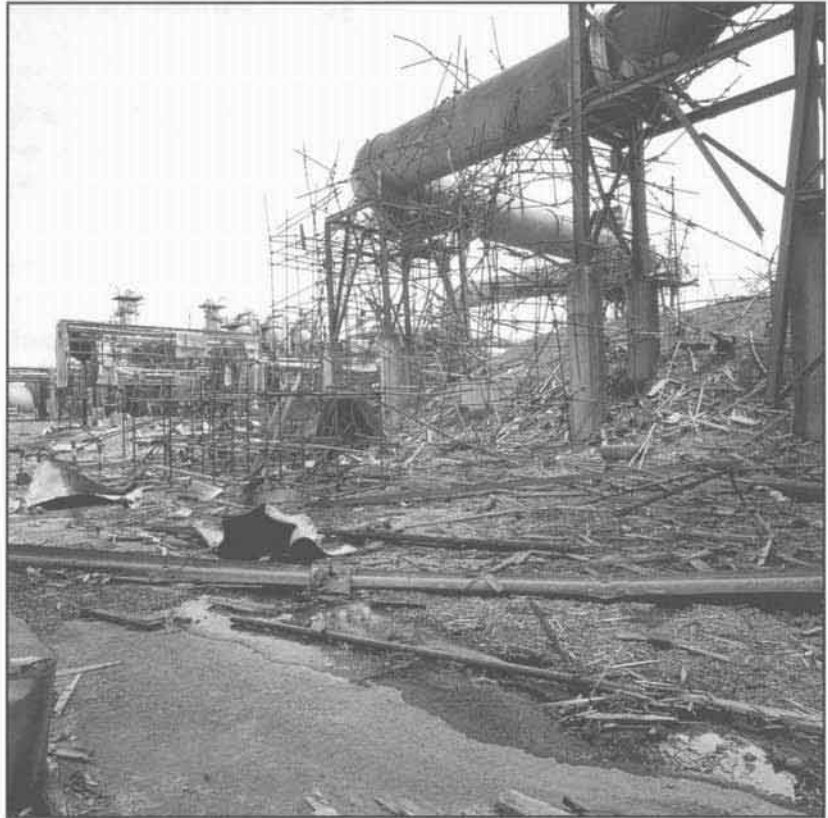
Figure 7 Some very large structures, such as the ducting weighing several tonnes shown here, were left balanced in dangerous positions after the explosion

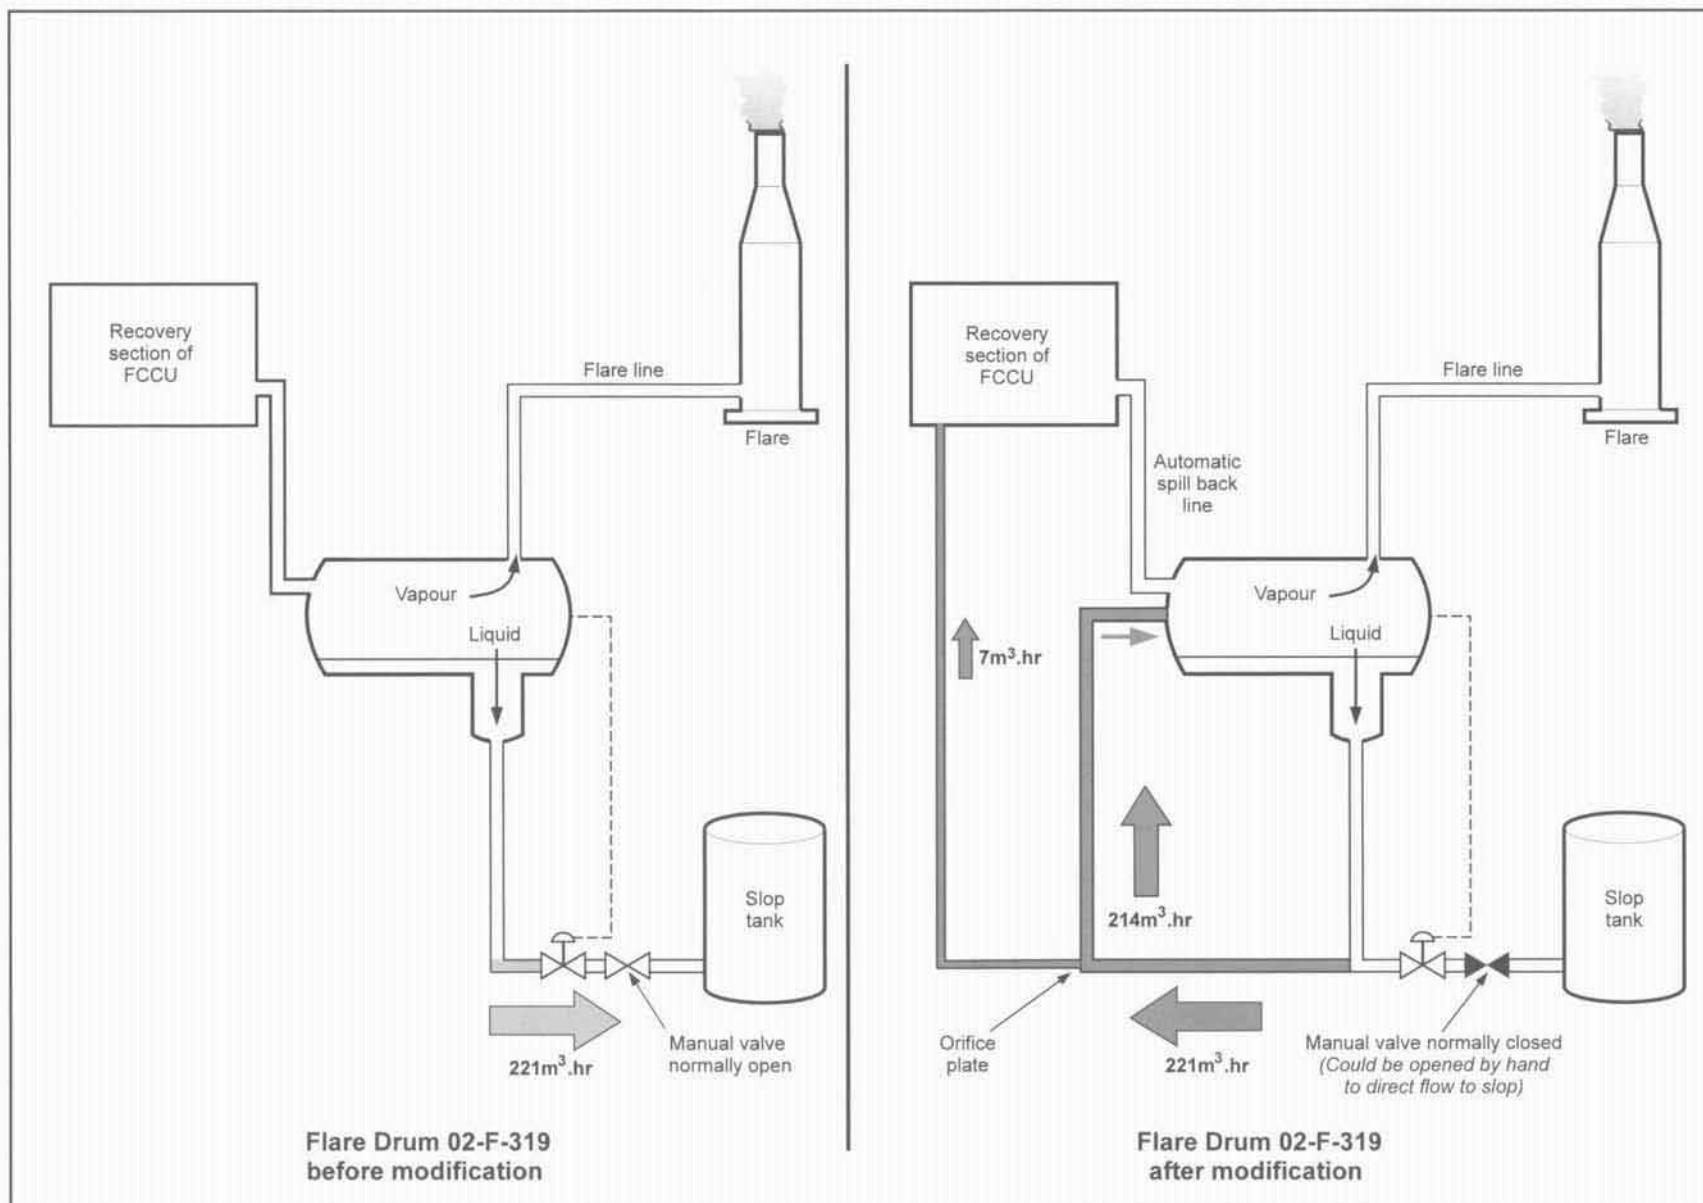
The flare drum is an important part of the flare system, which during the incident was relieving overfilled vessels. An earlier modification to its pump-out system severely reduced its automatic liquid handling capacity. It overflowed, causing liquid to enter an outlet designed for gas only. This consequently failed, releasing the flammable hydrocarbon in a cloud which exploded.

Figure 10 Diagrams to illustrate the modification to the flare knock-out drum pump-out arrangements
