**Tank fires, BOPEC Bonaire,**  
8-11 September 2010

**TANK FIRES, BOPEC BONAIRE,**  
8-11 SEPTEMBER 2010

## THE DUTCH SAFETY BOARD

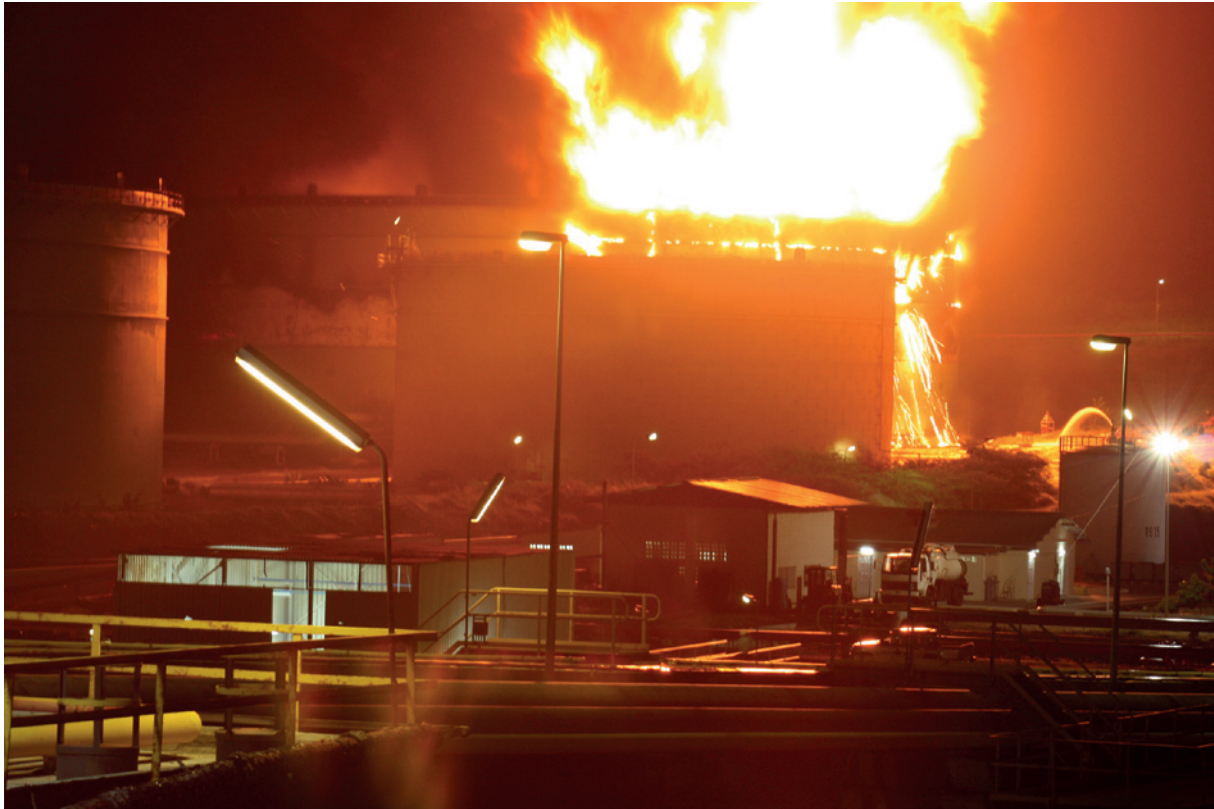
Figure 5: Escalation of the fire<sup>37</sup>

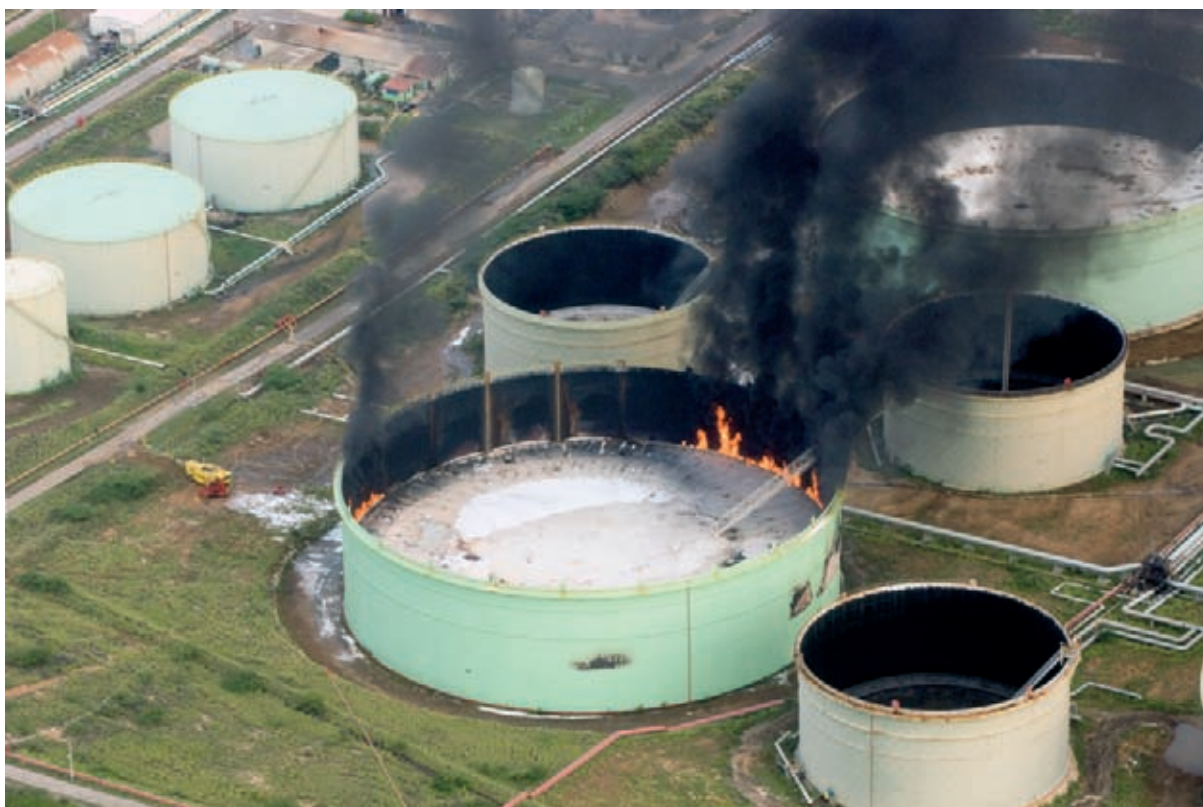
The two fires at BOPEC broke out at multiple points along the seal between the floating roof and the wall of the storage tanks in question immediately after a lightning strike on 8 September 2010. A lightning strike is a discharge of electricity from the sky to the earth that sometimes passes through a good conductor if one is present at the location concerned. Steel storage tanks are good conductors.

*Figure 6: The fire in tank 1931 on 8 September 2010 at 5.22 p.m.<sup>38</sup>*

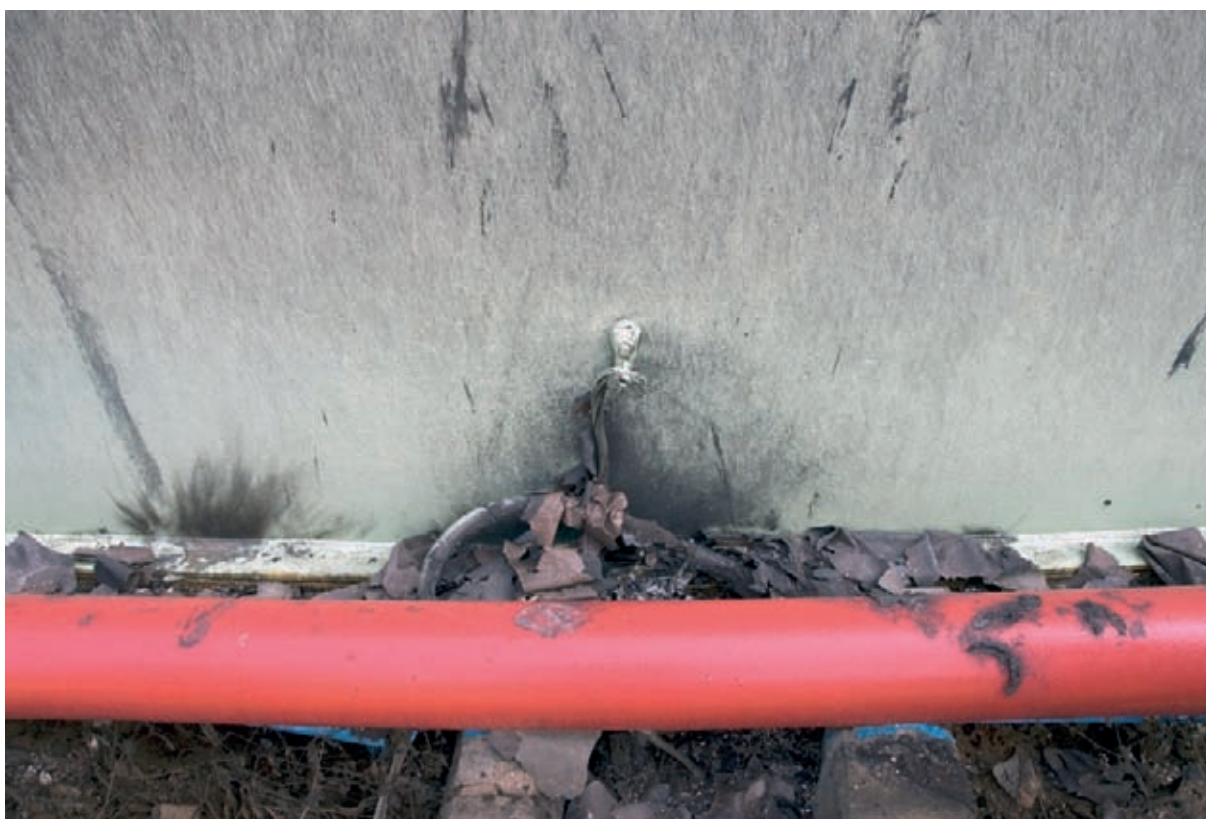
*Figure 7: The outside of the wall of tank 1931 with fresh soot marks caused by spark discharge on the left-hand side, the earthing cable and the melted electricity cable*

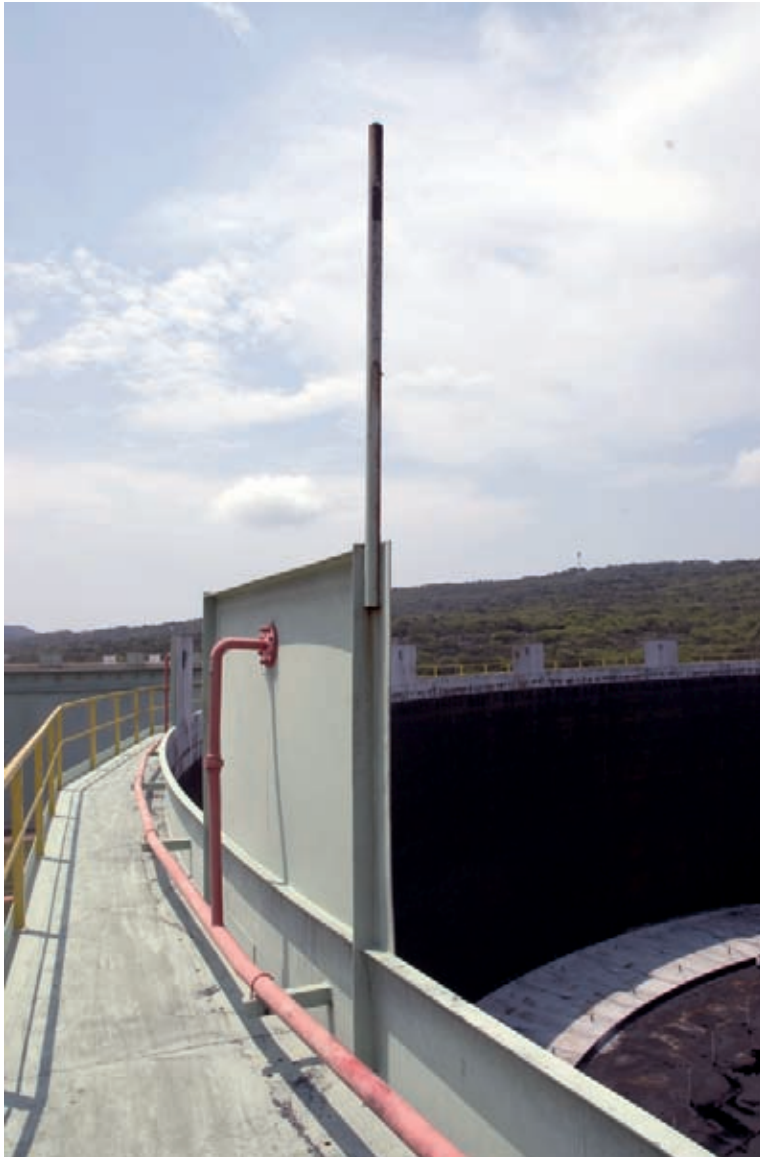
Figure 9: Scaffolding pipe on tank 1901

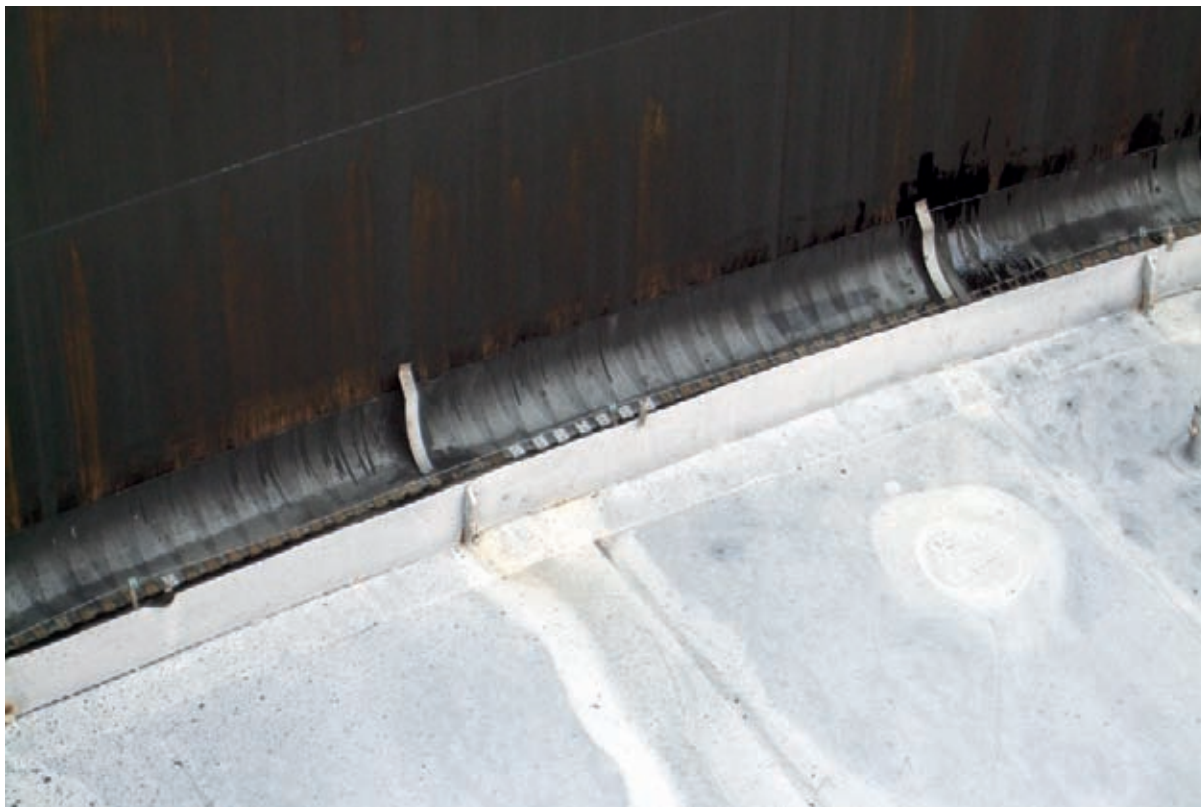
American Petroleum Institute assumes a space of no more than 3 m between shunts.<sup>68</sup> According to the latest Recommended Practice published in 2009, the contact point between the shunt and the tank wall must be at least 30 cm below the surface of the liquid in the tank.<sup>69</sup> The investigators from the Safety Board saw that the shunts on tank 1901 were above the seal (Figure 10). The file on tank 1931 does not contain any information stating that the floating roof in tank 1931 was fitted with shunts.

Figure 10: The floating roof in tank 1901 with shunts above the seal

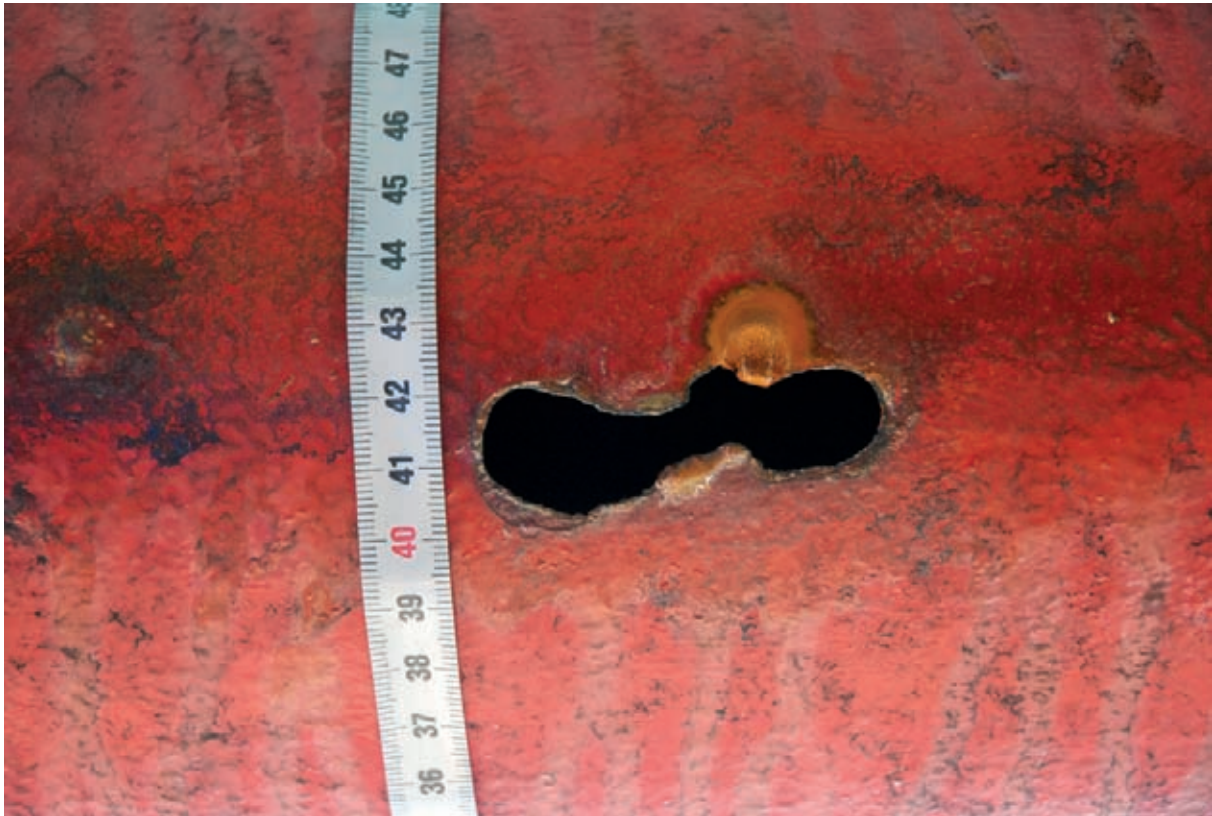
*Figure 12: Hole in the underside of the pipe to tank 1901*

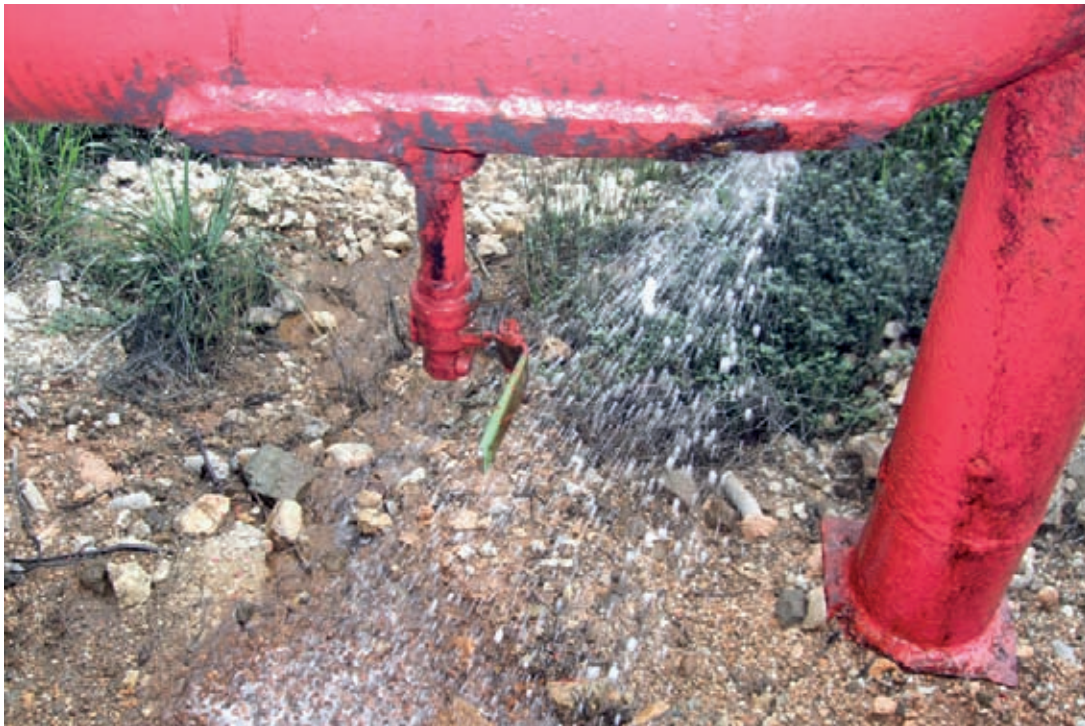
*Photo 1: Leak in a water pipe (source: Dutch Safety Board, dated 13 September 2010)*

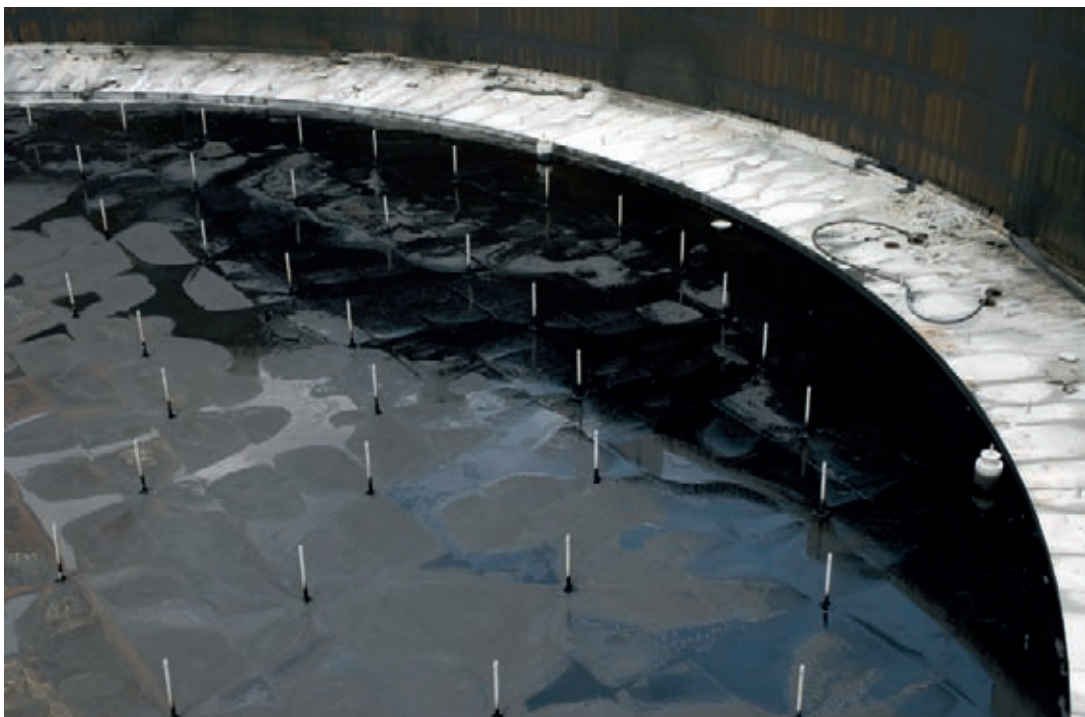
*Photo 2: Roof 1901 with open manholes and a dirty roof and walls (source: Dutch Safety Board, dated 13 September 2010)*

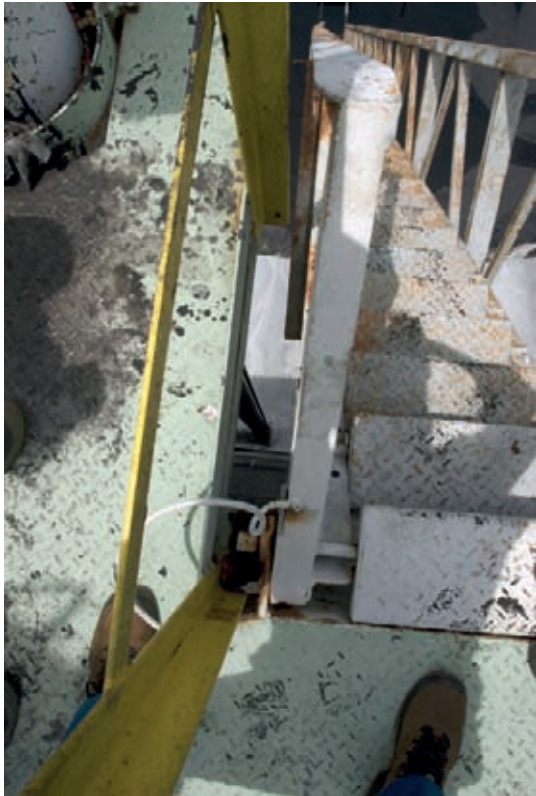
*Photo 3: Tank 1901, loop in connecting cable, stairway/wall (source: Dutch Safety Board, dated 13 September 2010)*

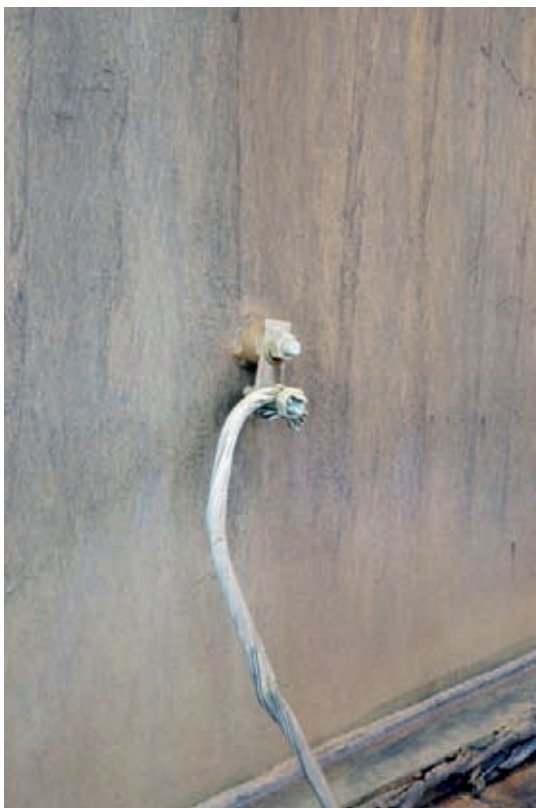
*Photo 4: Tank 1931, earth connection, covered with paint (source: Dutch Safety Board, dated 13 September 2010)*

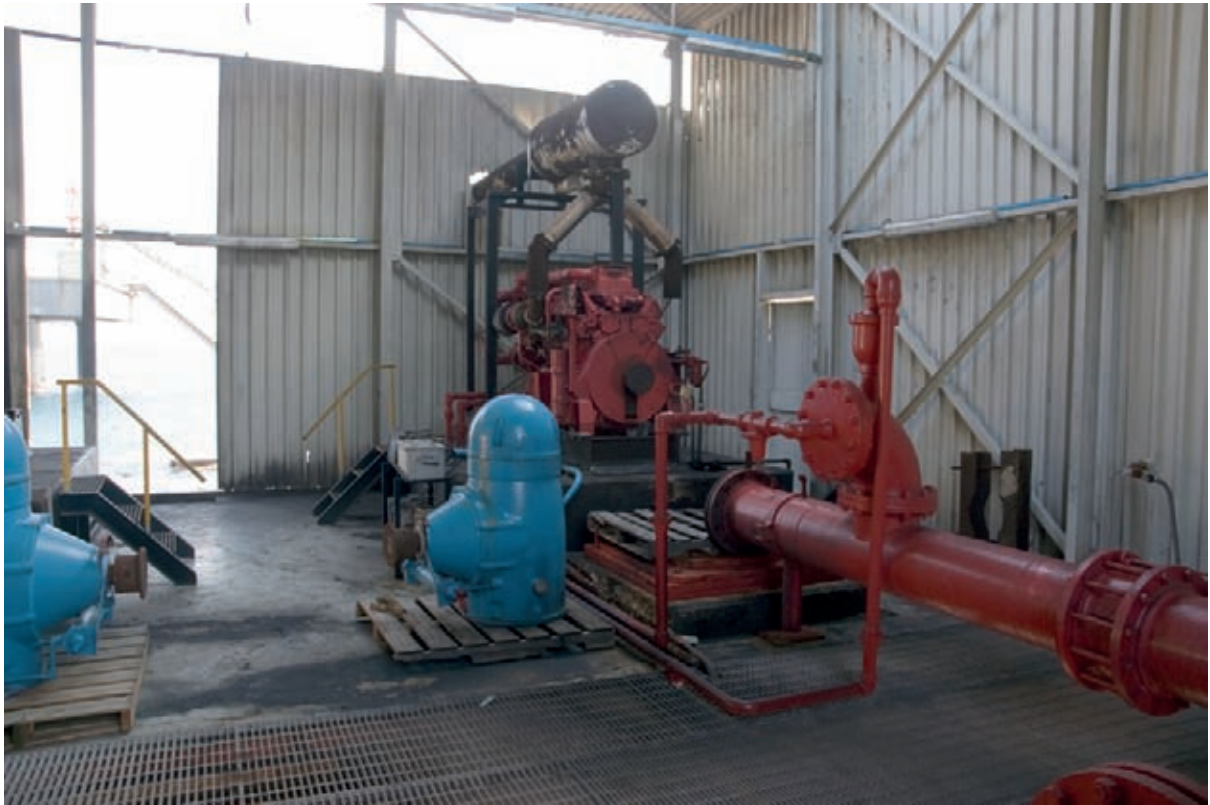
*Photos 5 and 6: Both fire-extinguishing pumps (blue) and a pallet (source: Dutch Safety Board, dated 13 September 2010)*

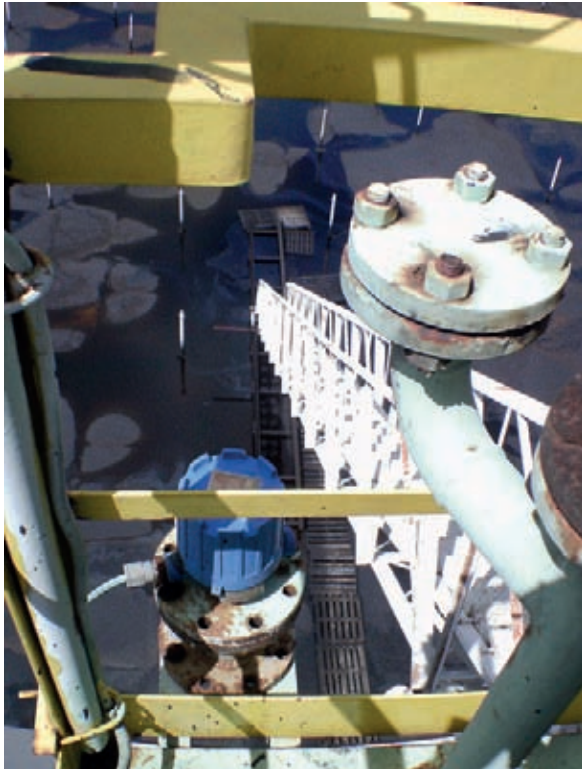
*Photo 9: Tank 1906, pallets and water on the tank roof (source: Dutch Safety Board, dated 16 February 2011)*

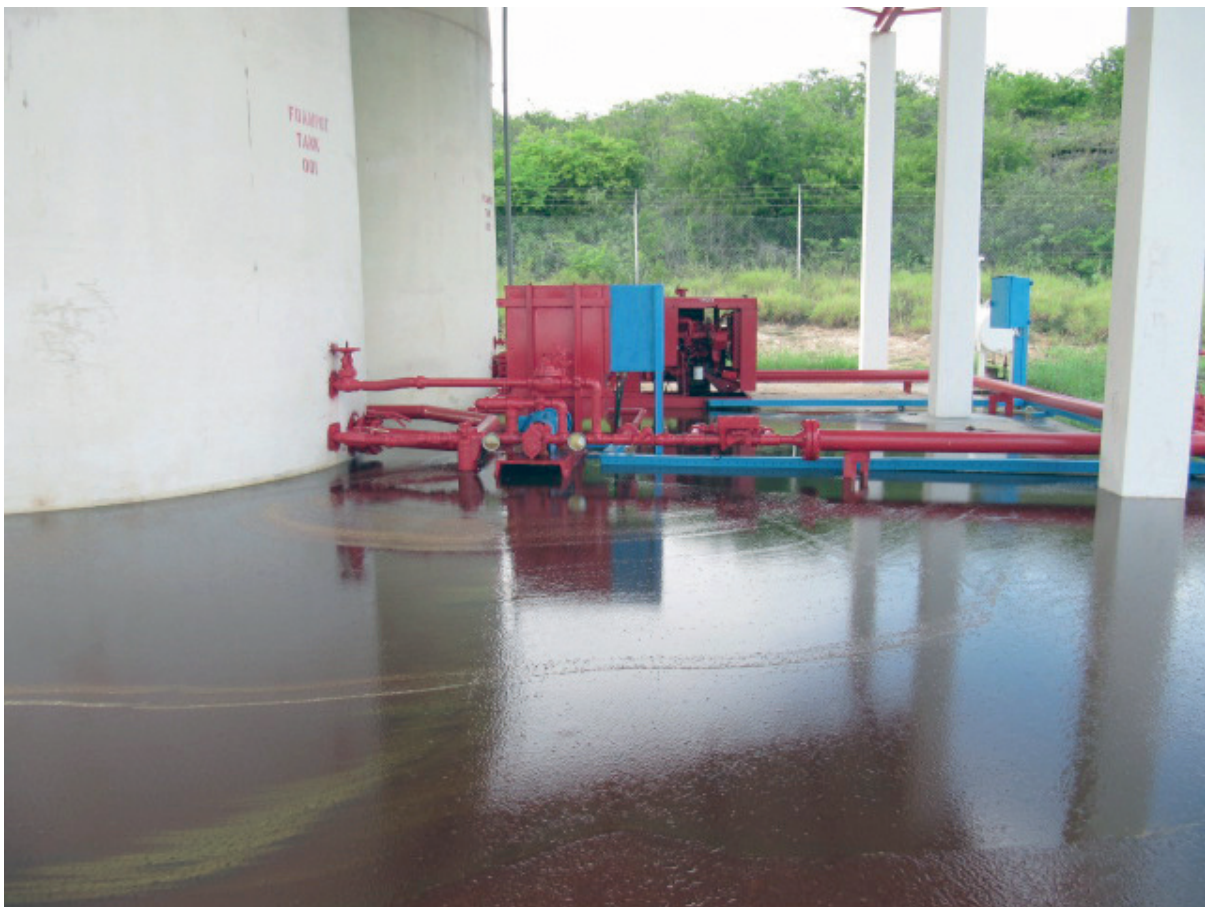
*Photo 10: Storage tank with foaming agent in the pool (September 2010)*

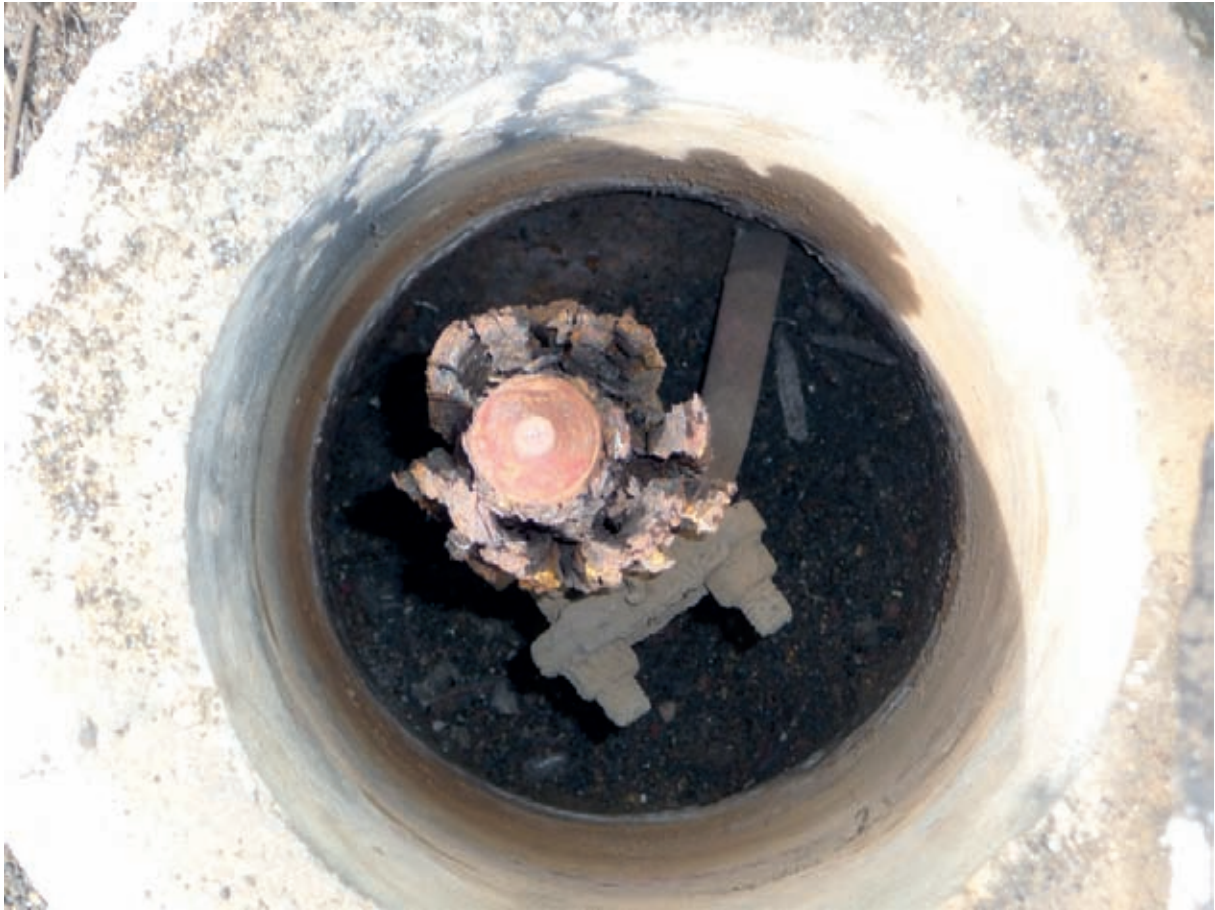
*Photo 11: Tank 1934, corroded earthing pins (source: Dutch Safety Board, dated 16 February 2011)*

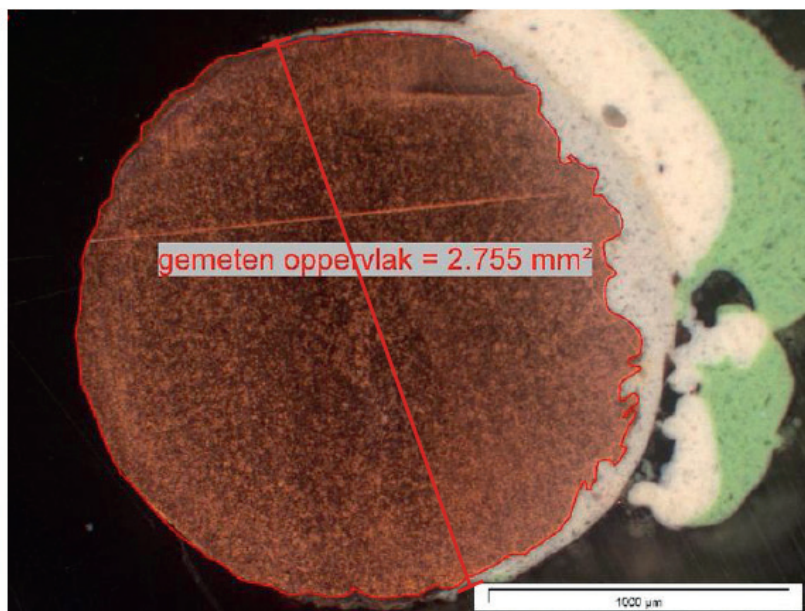
**Figuur 3.** Dwarsdoorsnede over de draad. Het oppervlak van het koper bedraagt 2,755 mm<sup>2</sup>. De diameter was op deze positie bepaald op 1,93 mm.

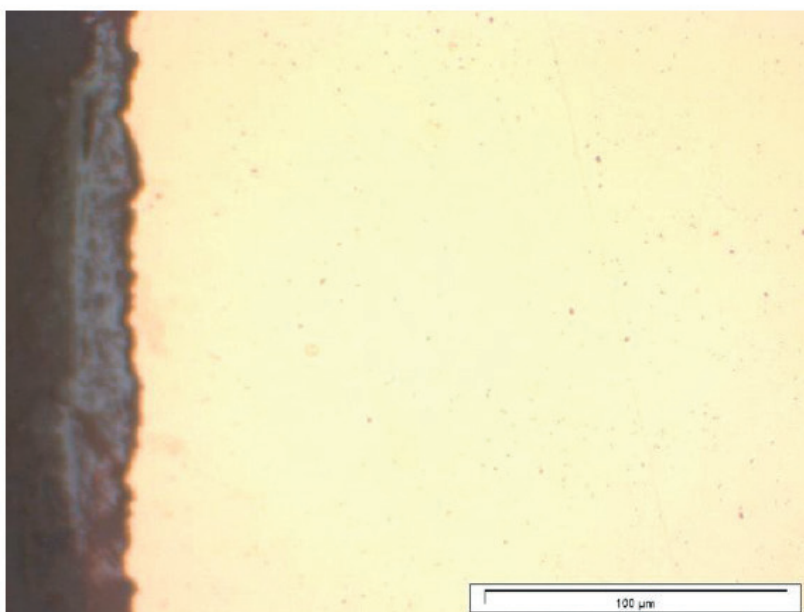
**Figuur 4.** Dwarsdoorsnede over de draad. De oxideverdeling aan de rand van de draad.

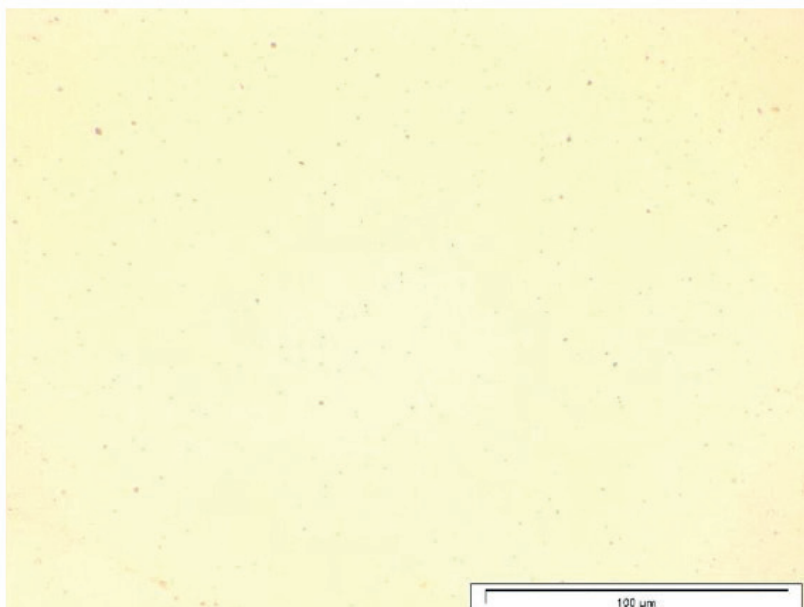
**Figuur 5.** Dwarsdoorsnede over de draad. De oxideverdeling in de kern van de draad.

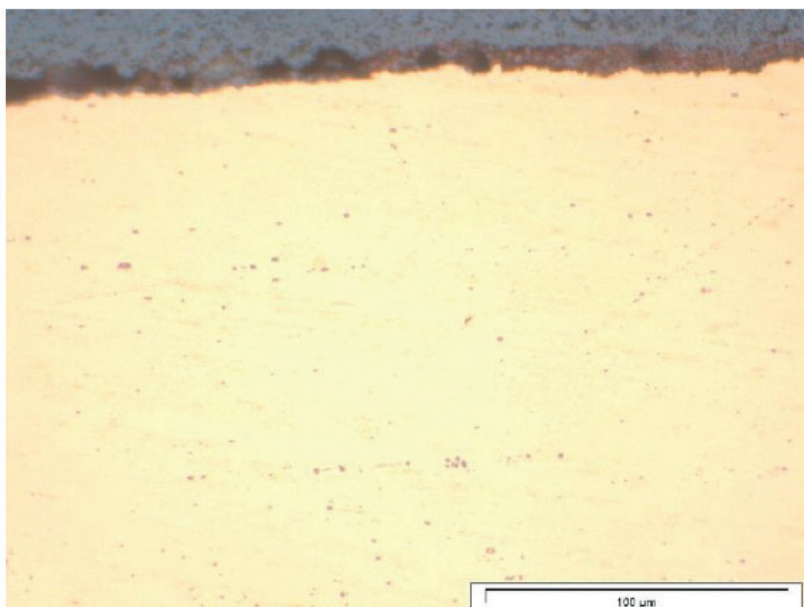
**Figuur 6.** Langsdoorsnede over de draad. De oxideverdeling aan de rand van de draad.

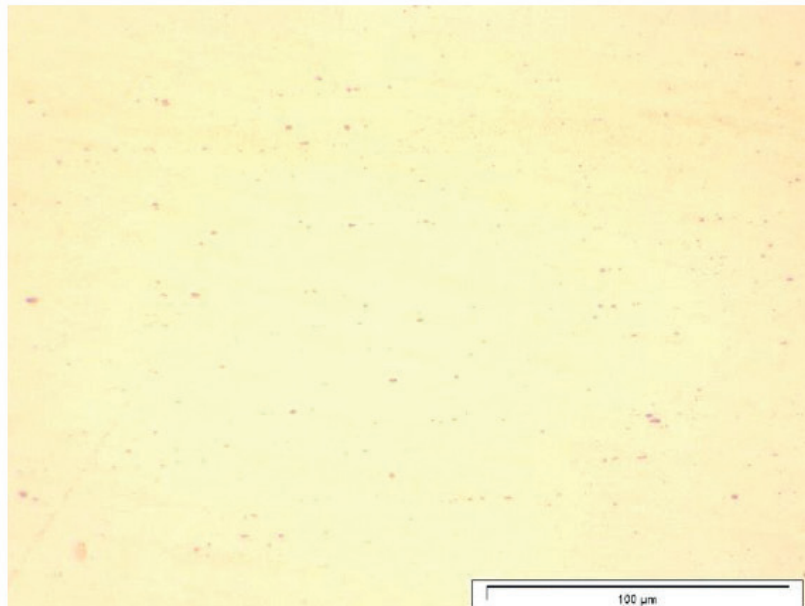
**Figuur 7.** Langsdoorsnede over de draad. De oxideverdeling in de kern van de draad.

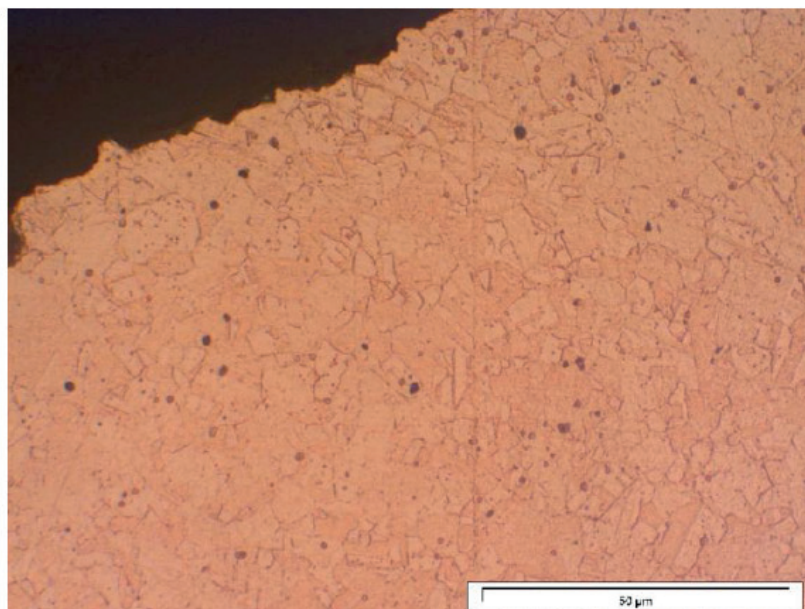
**Figuur 8.** Dwarsdoorsnede over de draad. De microstructuur aan de rand van de draad.

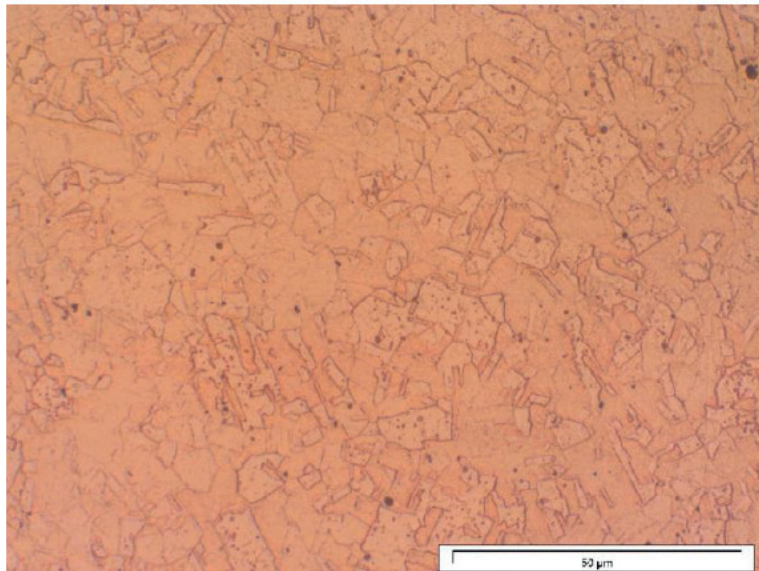
**Figuur 9.** Dwarsdoorsnede over de draad. De microstructuur in de kern van de draad.
