# GMOSAIC

CRITICAL ASSETS MONITORING

## Refinery Bío Bío, Concepción/Talcahuano, Chile

<b>Grant Agreement number:</b>	031046 Collaborative Project
<b>Project acronym</b>	G-MOSAIC
<b>Project title</b>	GMES Services for Management of Operations, Situation Awareness and Intelligence for regional Crises
<b>Funding Scheme:</b>	SEVENTH FRAMEWORK PROGRAMME - THEME 9 Space
<b>Thematic Priority</b>	PRIORITY 4 AERONAUTICS & SPACE – SPACE 2005 FP6-2005-Space-1 / GMES Security
<b>Project starting date:</b>	01 January 2009
<b>Project duration:</b>	36 months
<b>Project coordinator:</b>	Telespazio <a href="mailto:gmosaic@telespazio.com">gmosaic@telespazio.com</a>
<b>Deliverable reference number</b>	RGR002-CTA-CAE-03-CHILE-02/04/05 Report
<b>Date of deliverable</b>	05/03/2010
<b>Issue. Revision</b>	1.0
<b>Abstract</b>	Report of the satellite based analysis carried out over the Refinery of Bío Bío, Concepción/Talcahuano, Chile, prior and posterior to the 8.8 magnitude earthquake on 27.02.2010, 3:40 local time

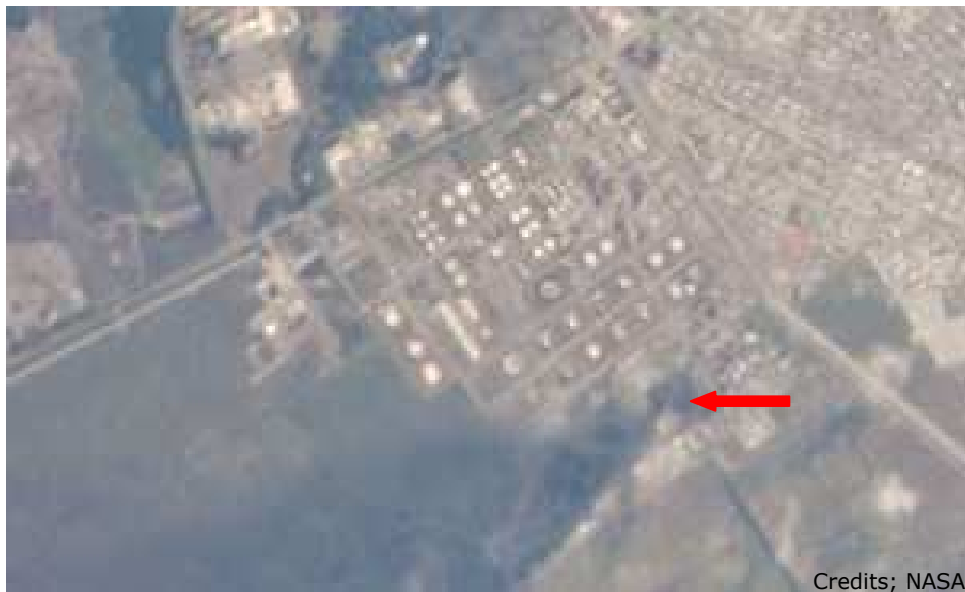
Figure 2: A zoom on the Bío Bío site of the above mentioned ISS image (taken 7 hours after the earthquake); the red arrow shows the location of the origin of the plume.

- The big dark smoke plume as can be seen on the ISS imagery (figure 2), is also visible on the Rapid Eye image. The plume comes from different flare stacks situated in the South of the plant (see the red flare stack icon in figure 3). The flare stacks are part of a blowdown system, which permits the removal of liquids and vapors from process units in order to permit shutdown of the process unit for maintenance/repair or to prevent dangerous high temperature or high pressure conditions from occurring in it. A refinery blowdown system allows safe transfer of process liquids or vapors out of each process unit. The flare stacks are responsible for destroying these high concentration air emissions. Flaring of natural gas from oil & gas wells is a significant source of greenhouse gas emissions.

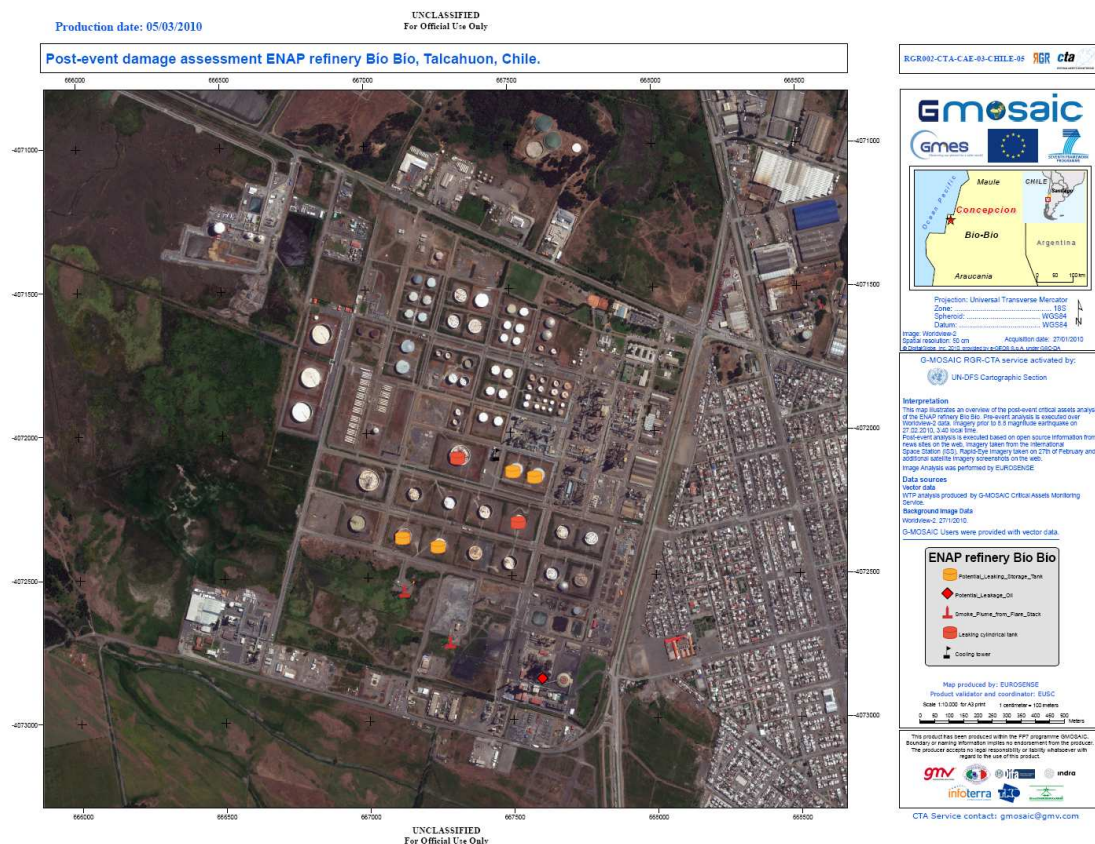
Figure 3: Post-event analysis of ENAP refinery Bío Bío.

- Several tanks have considerable damage. 2 of them (see red tank icon in figure 3) at least are seriously damaged and oil has leaked in a rather big proportion out of the tank. For at least 4 other tanks (see orange tank icon in figure 3) there are some indications of damage; however this cannot be stated decisively.
