The collapse of the San Rafael waterfall on Feb. 2 and the accelerated regressive erosion that began to occur on the riverbed and edges of the Coca River have turned into a huge problem for the Ecuadoran government.

## Four kilometers of erosion in five months

## The action plan to tackle regressive erosion

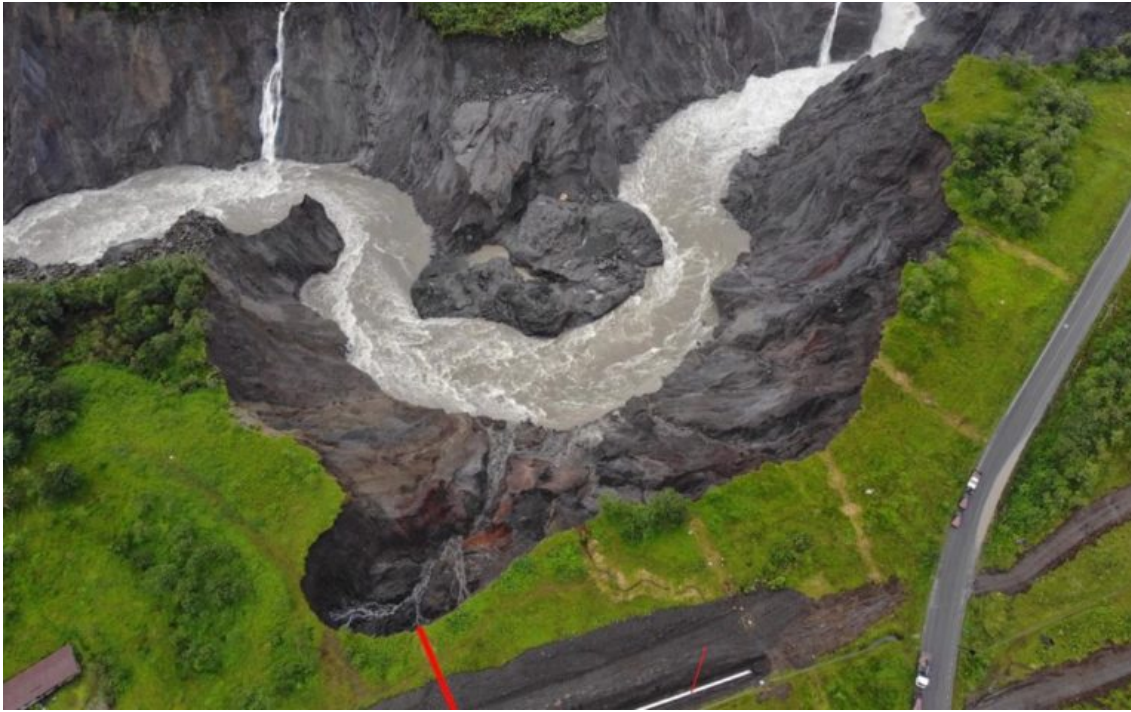
*The SOTE pipeline temporarily stopped operations on June 3, 2020, due to the advance of lateral erosion on the Coca River. Image courtesy of Petroecuador.*

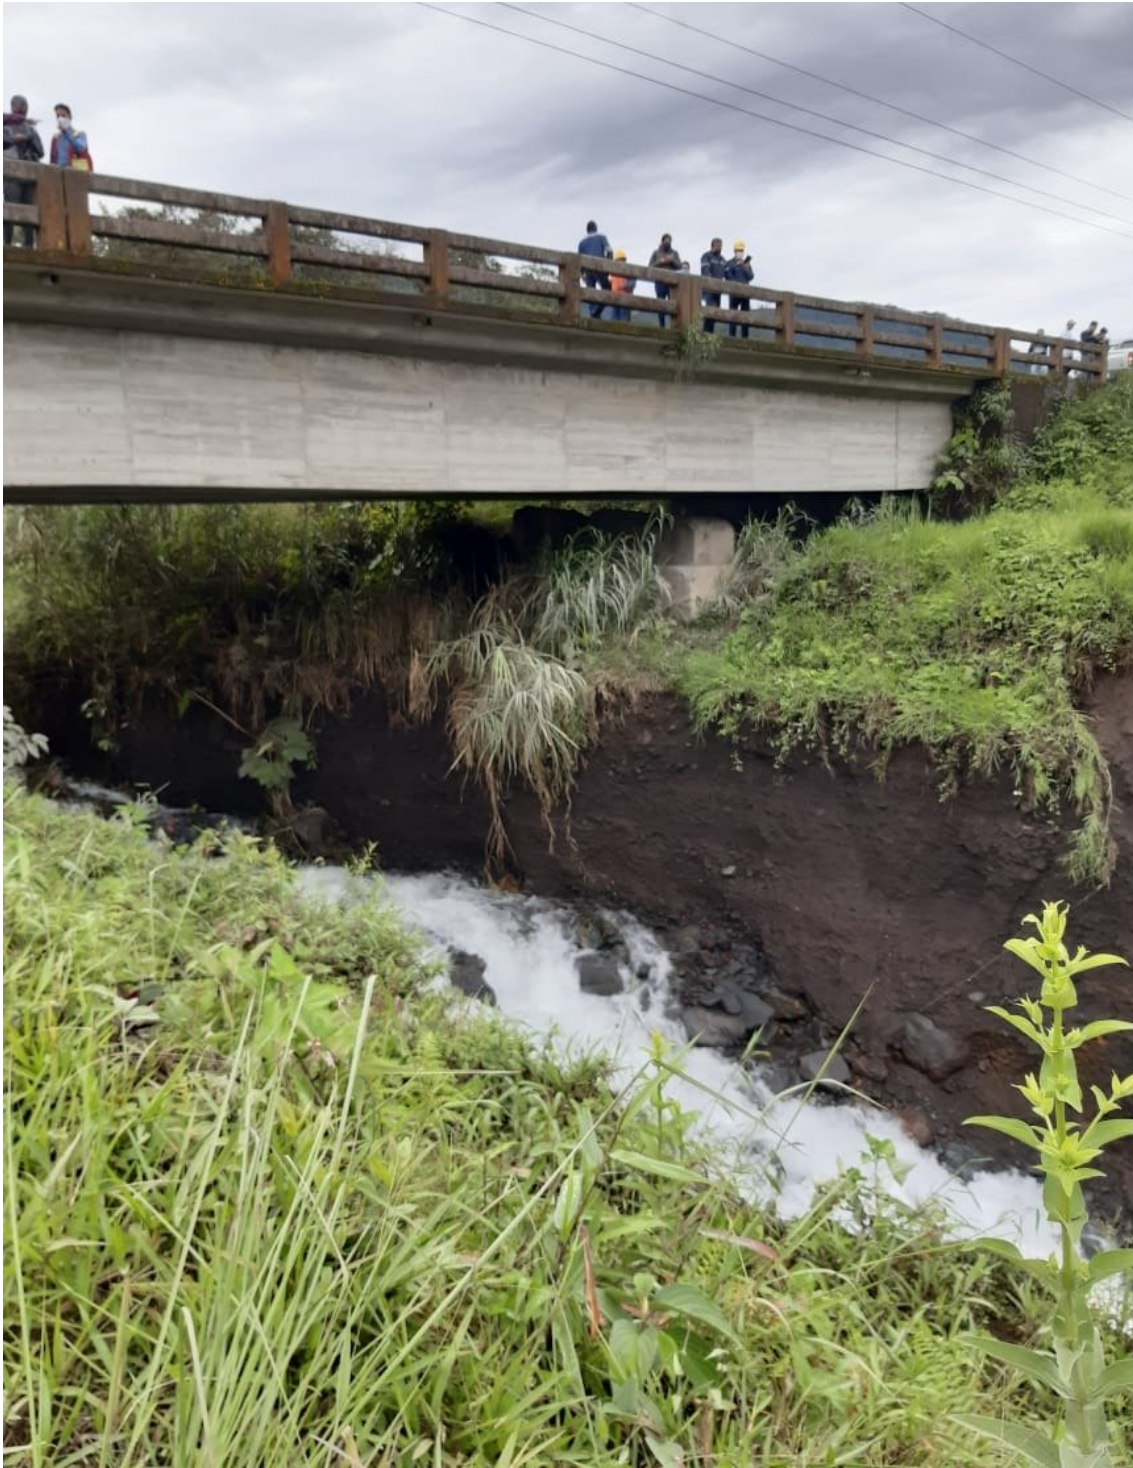
*Erosion of the Montana River on June 4, 2020, beneath the Baeza-Lago Agrio bridge.  
Image by Alfredo Carrasco.*

One of Cobo and Carrasco's main concern is that since June, erosion has already been seen not only progressing along the Coca River but also along one of its tributaries, the Montana River. This has put at risk a bridge on the Baeza-Lago Agrio road. The road had to be closed as a precaution for more than a month.

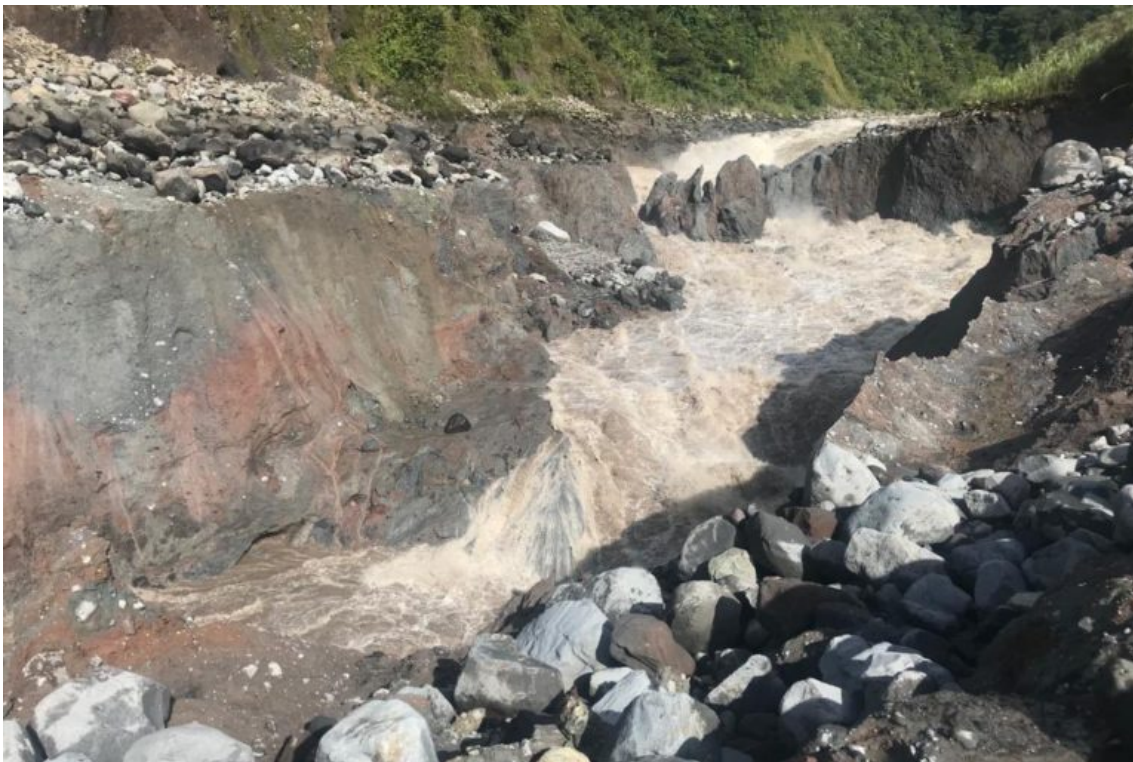
*In 52 hours, the Coca River receded more than 400 meters (1,300 feet). In the absence of consolidated rocky debris, the Coca Codo Sinclair dam could be in serious danger. Photo from July 3, 2020. Image by Alfredo Carrasco.*

Carrasco has visited the area on several occasions and has been closely monitoring the erosion. He said he reached the Coca River on July 1 and found that the regressive erosion was no longer at the confluence of the Montana and Coca rivers, but 450 meters (nearly 1,480 feet) upstream. When he left the region, on July 3, the erosion had advanced by another 475 meters (1,560 feet).

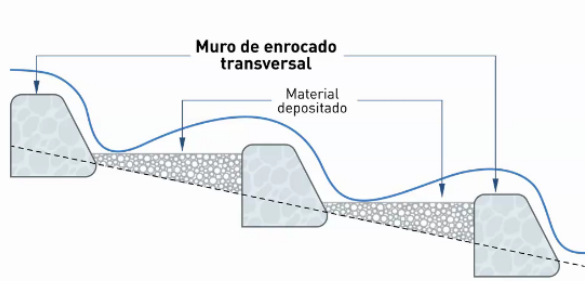
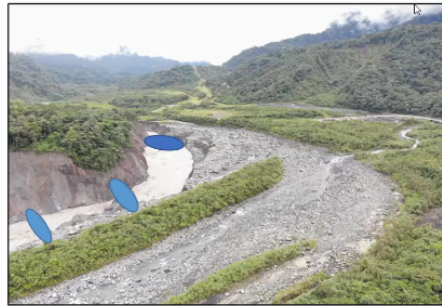
### Fase I – Construcción obras emergentes

- Construcción de muros de enrocado en el cauce del río Coca cuya finalidad es disminuir la velocidad de caudal de agua y por lo tanto mitigar el fenómeno de erosión regresiva.

- Ampliación cauce del río Coca.

**Inicio:** 15 julio 2020  
**Duración:** 90 días

*A proposed plan for new infrastructure by the Ecuadoran government to slow the erosion of the riverbed. Image courtesy of the Ministry of Energy and Non-Renewable Resources.*

On July 9, the energy ministry announced the outcome of the consultants' studies and declared that the construction of new infrastructure would begin in the middle of the month. "As of July 15, the construction of a ramp that will be set in the river will begin. Also, the channel will be expanded to alleviate the force of the flow," Ortiz said. That would be only the first phase of the action plan. At the same time, a second phase will begin, consisting of several stages: commissioning a series of complementary studies, which must be done no later than Sept.

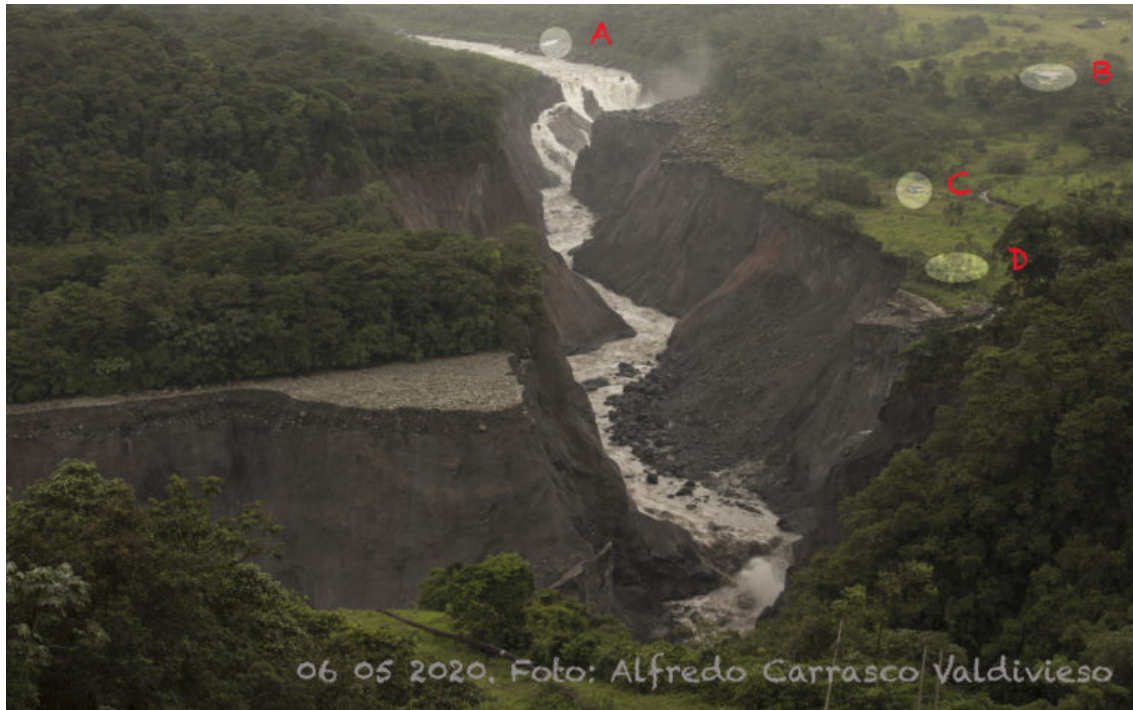
*The advance of the erosion of the Coca River on May 6, 2020. Image by Alfredo Carrasco.*

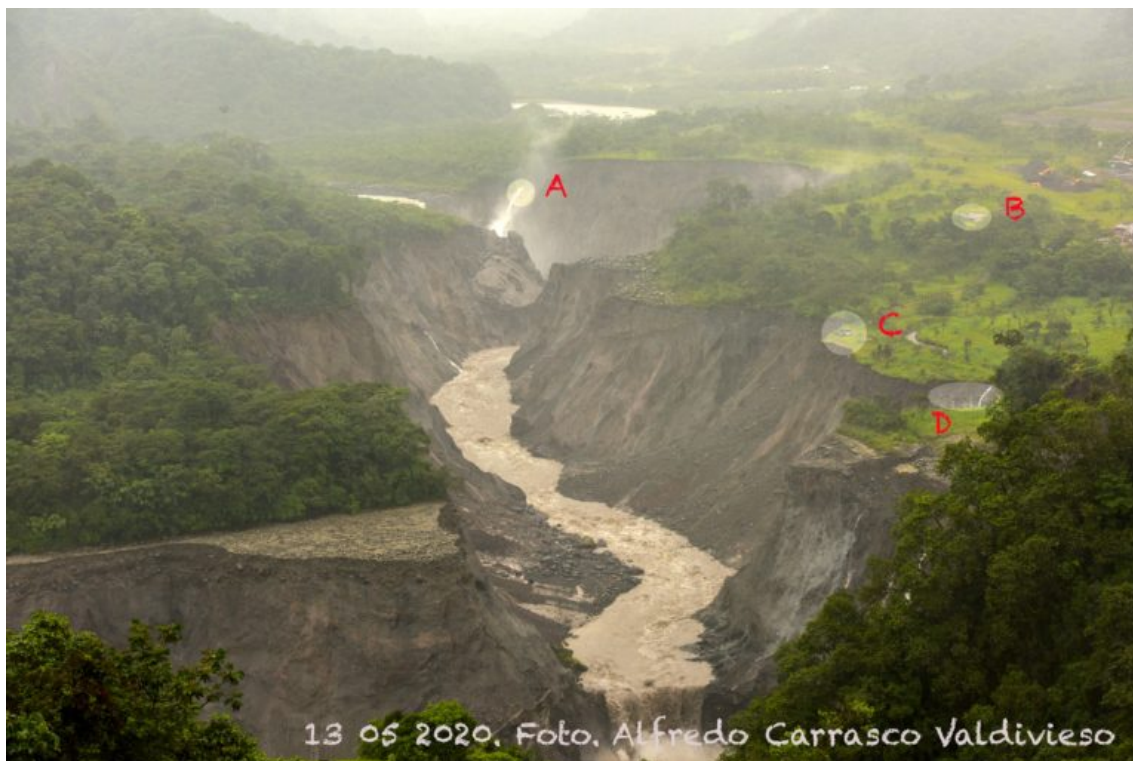
*The advance of the erosion of the Coca River on May 13, 2020. Image by Alfredo Carrasco.*

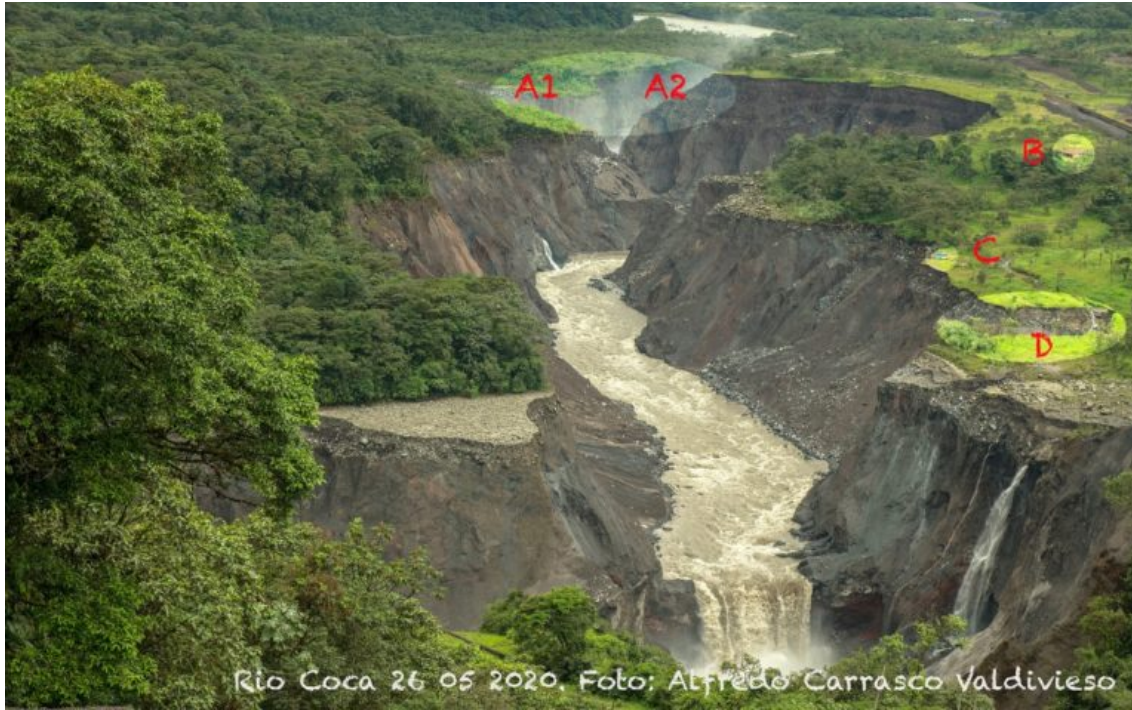
*The advance of the erosion of the Coca River on May 26, 2020. Image by Alfredo Carrasco.*

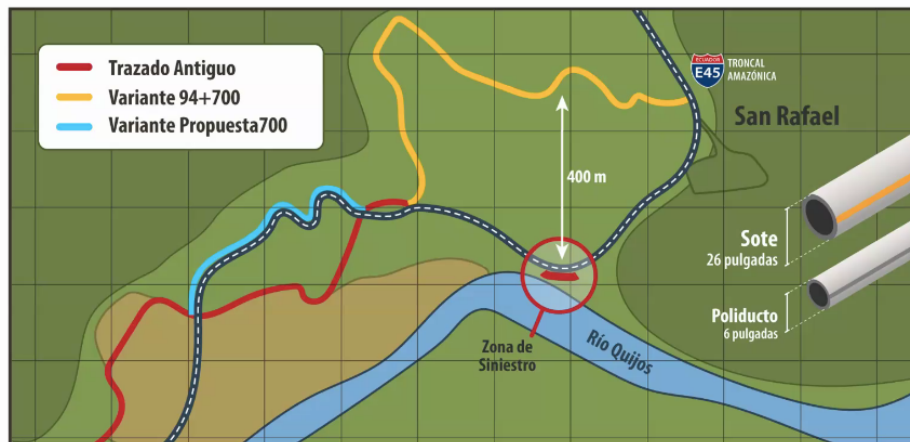
## Acciones EP Petroecuador

*Maps of the bypass lines for the SOTE and Shushufindi pipelines. Image courtesy of the Ministry of Energy and Non-Renewable Natural Resources.*

The vice minister of hydrocarbons, María Elisa Soledispa, said Petroecuador has built two bypass lines for each of the two pipelines that collapsed in April — the Trans-Ecuadoran Oil Pipeline System (SOTE) and the Shushufindi-Quito Polyduct — which has allowed it to move between 200 and 400 meters (660 and 1,310 feet) from the riverbed of the Coca River, especially at the confluences of the Marker and Montana rivers. The first bypass for SOTE was built in April, running 1.75 km (1.09 mi); construction on the second began in May and will run 1.1 km (0.7 mi). The first bypass for the polyduct, meanwhile, runs 1.32 km (0.82 mi) and the second 1.8 km (1.1 mi). Soledispa said a third bypass is planned for SOTE that will have an extension of 0.79 km (0.49 mi). OCP's Grijalva told Mongabay that the company built a 1.7-km (1.06-mi) bypass in the eroded area to reestablish crude exports.
