Massive erosion likely due to hydropower dam causes oil spill on Ecuador's Coca River

by Antonio José Paz Cardona on 6 May 2020 | Translated by Romina Castagnino

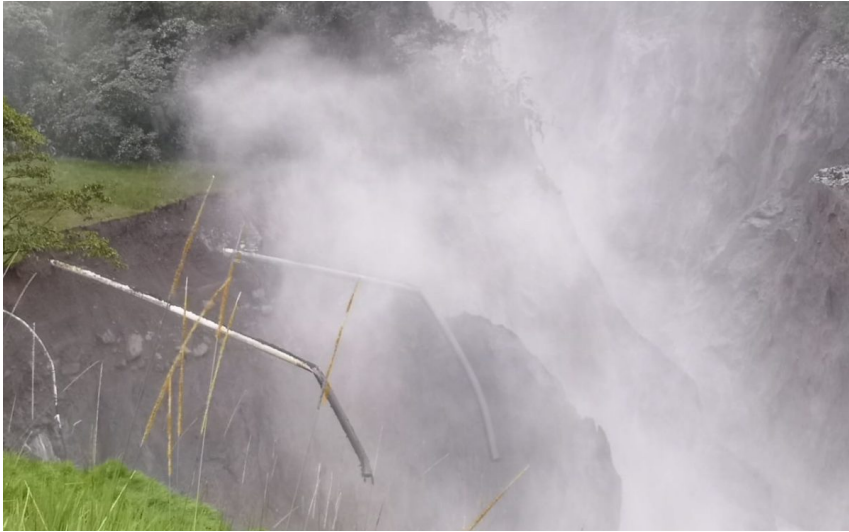
The bases and pipes of the Trans-Ecuadorian Oil Pipeline System and the heavy crude pipeline operated by OCP collapsed on April 7. Photo via private archive.

In short, he said, the waterfall has already receded to the area where this new collapse occurred, which ended up affecting the pipelines.

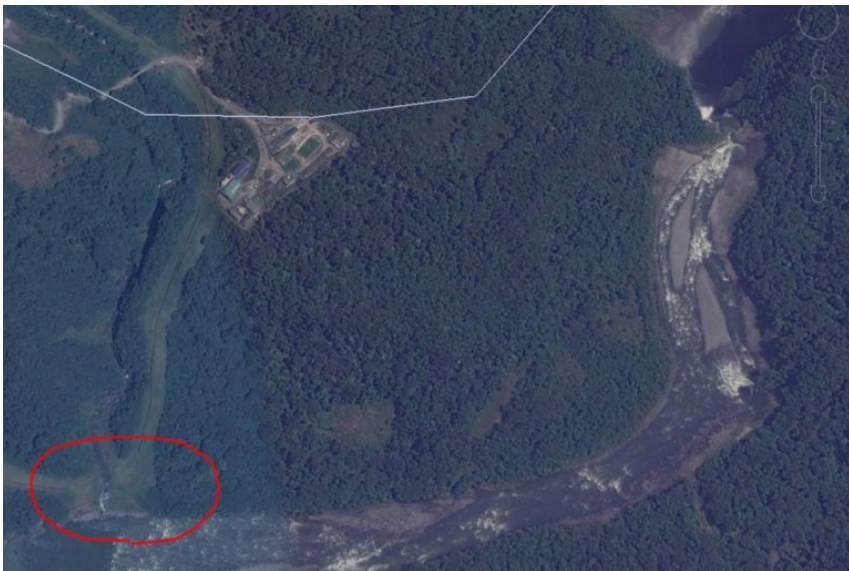
The new collapse occurred in the area marked with the red circle. Image from Google Earth.

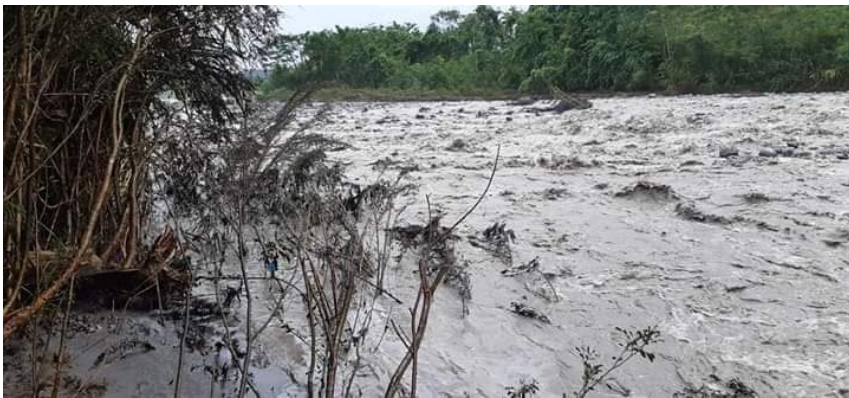
The Panduyacu community was one of the first to see oil slicks in the Coca River. Image courtesy of the Panduyacu community.
