Satellite images show oil spill in Chennai after Cyclone Michaung-induced floods

India Today's OSINT team maps the severity of the oil spill in Chennai following floods

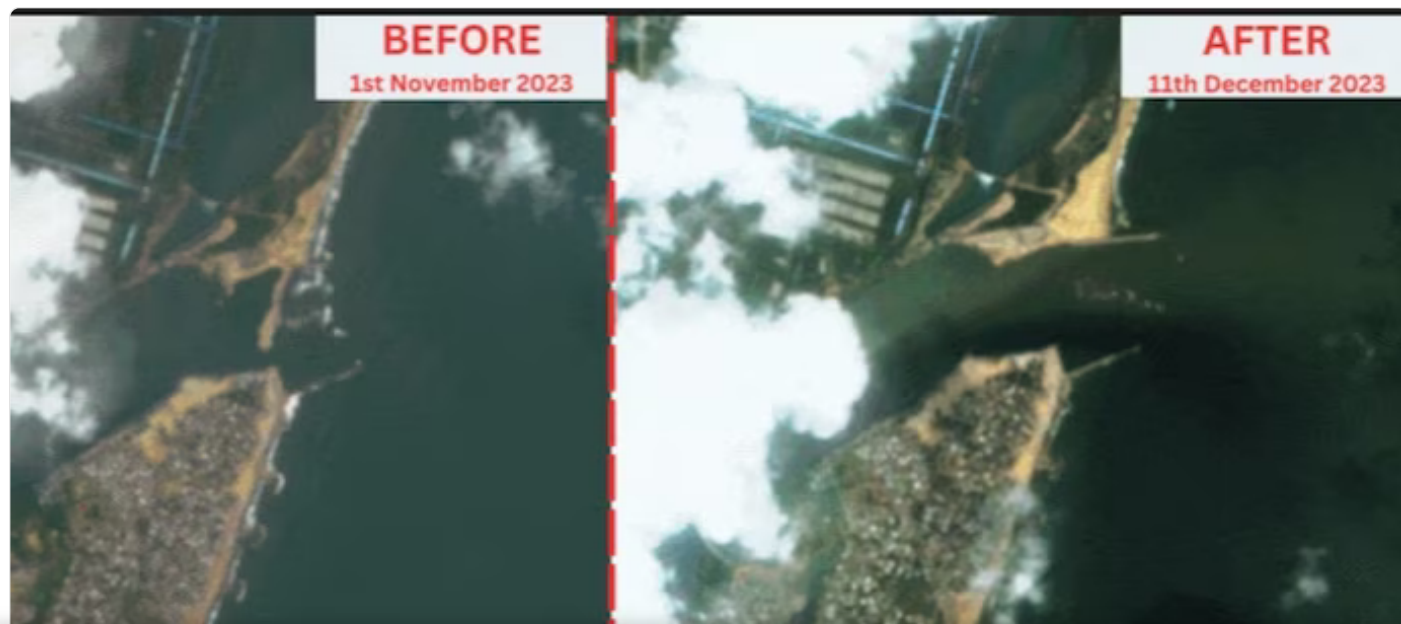
Ennore before (L) and after (R) the floods in Chennai following Cyclone Michaung

Satellite images from the Copernicus Sentinel Program accessed by India Today's Open-Source Intelligence (OSINT) team show the oil spill in large swathes floating through the Ennore Creek into the Bay of Bengal. We created a custom visualisation by using the Oil Spill Index (OSI) script of the Sentinel-2 satellite of the European

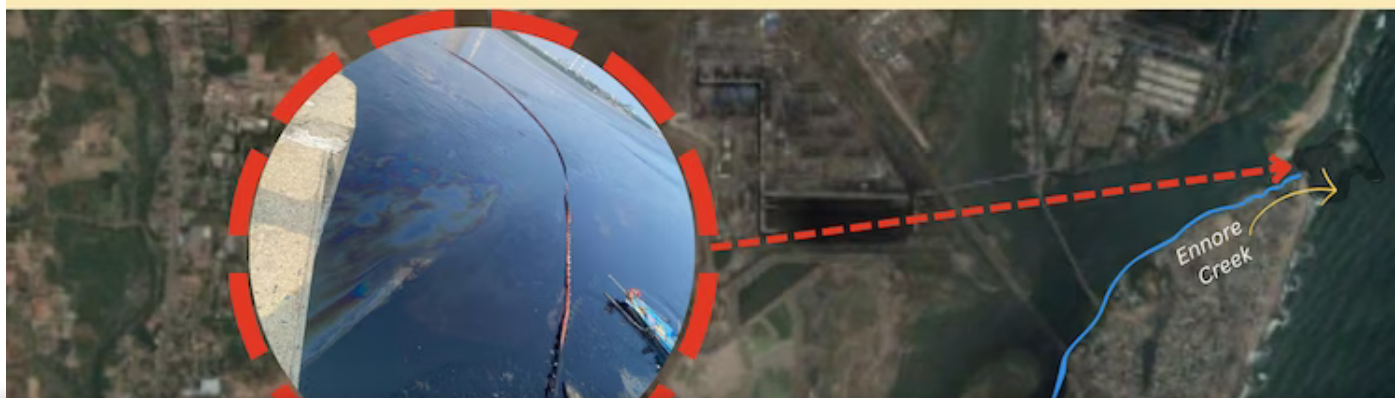
Cyclone Michaung: Tracking the route of Oil spill in Chennai

"The oil permeated from the CPCL plant into the floodwaters, which took it to nearby Buckingham Canal and a tributary of the Kosasthailayar river – polluting areas downstream on their way to the Ennore Creek," said Tamil Nadu-based mapper and urban development expert Raj Bhagat.

The CPCL, a subsidiary of the Indian Oil Corporation (IOL), was initially blamed by the local fishing community. However, the company denied any pipeline leaks at its Manali refinery. Further investigation by the Tamil Nadu government's State Oil Spill Crisis Management Group (SOS-CMG) traced the spill to the CPCL premises, where guard ponds and stormwater drain ponds emptying into the Buckingham Canal were identified as the source.
