# The 2003 Tokachi-oki Earthquake of September 26

## 1. Summary

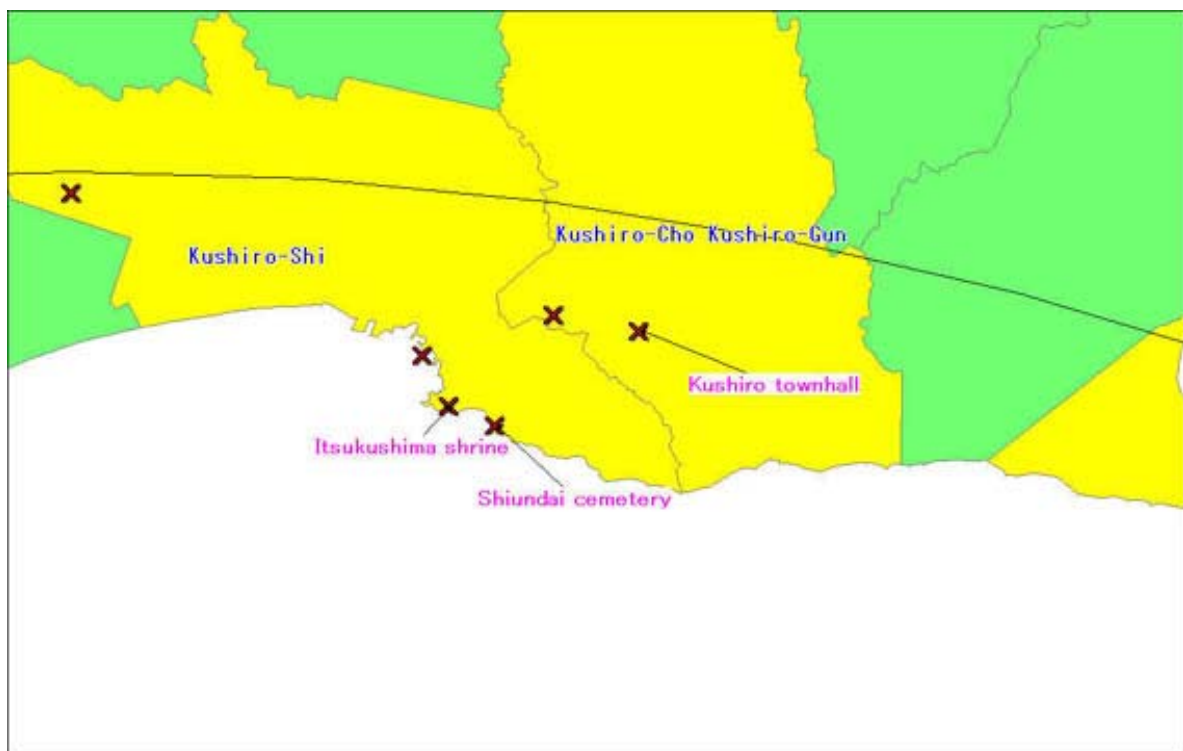
### <Kushiro-cho, Kushiro-gun>

In general, there was no significant damage in the cemetery even where the intensity was 5+, since the gravestones in the surveyed area were anchored with sealing materials. In Shiundai Cemetery, however, there were some overturned or slid gravestones (PHOTO 30, PHOTO 31 and PHOTO 32).

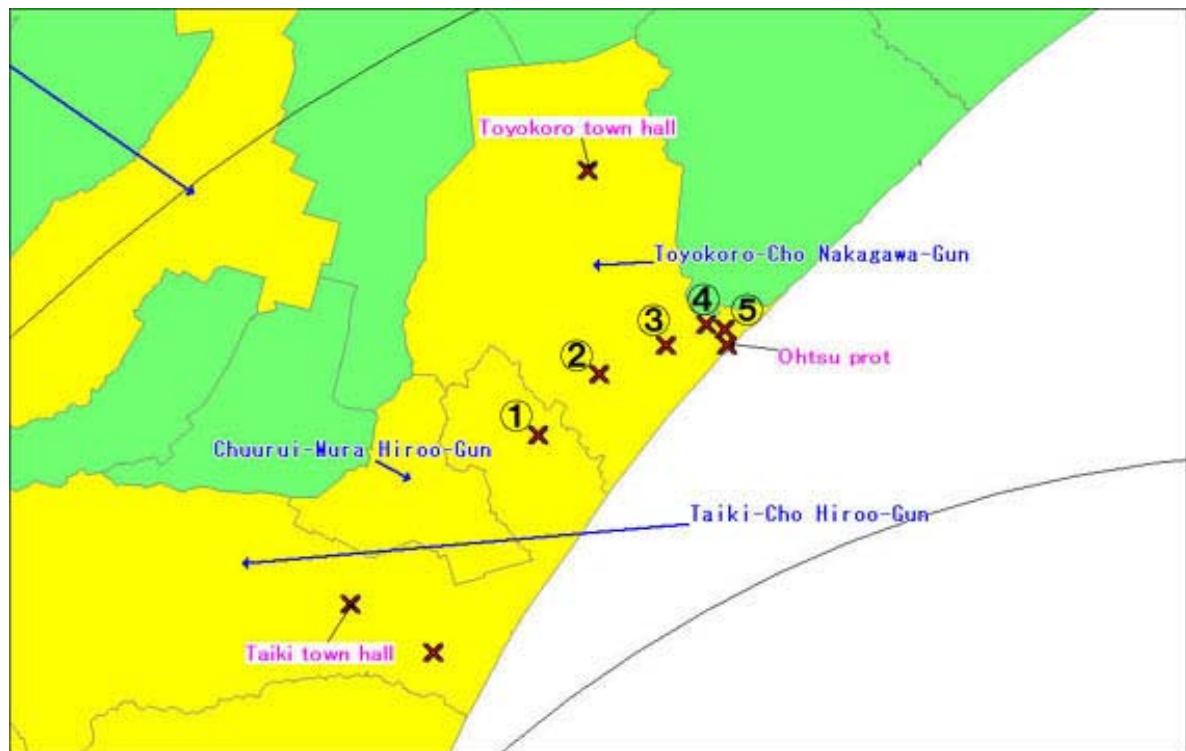
The bank in the mouth of the Tokachi River was severely torn down (PHOTO 43 and PHOTO 44).
