The explosion and fires at the Texaco Refinery, Milford Haven, 24 July 1994

**A report of the investigation by the Health and
Safety Executive into the explosion and fires on
the Pembroke Cracking Company Plant at the
Texaco Refinery, Milford Haven on 24 July 1994**

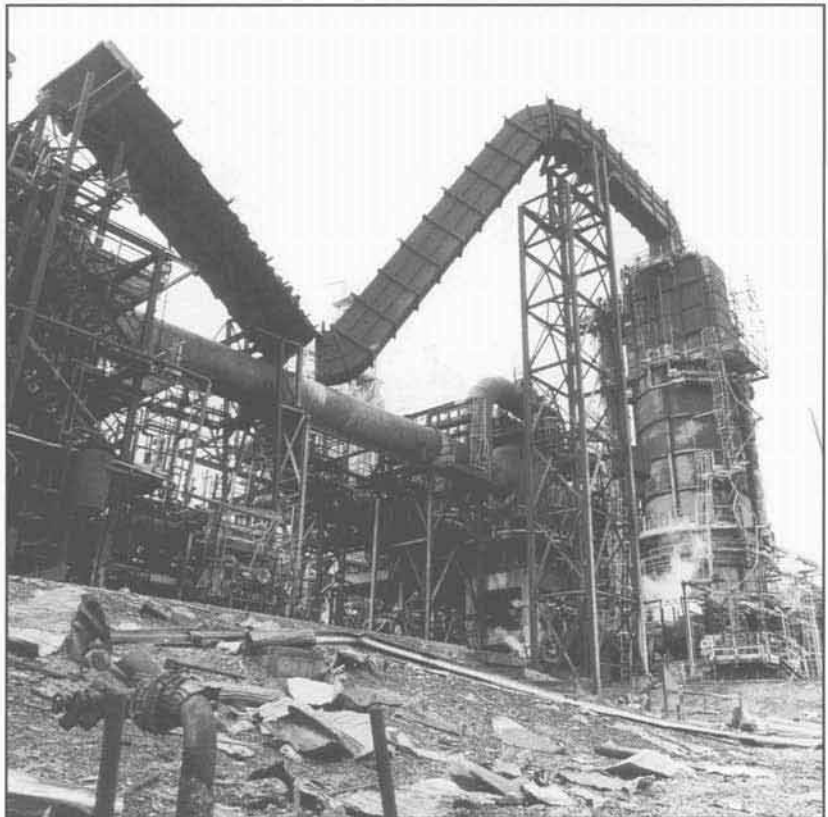
Figure 8 One of the HSE investigation team examines part of the debris following the incident

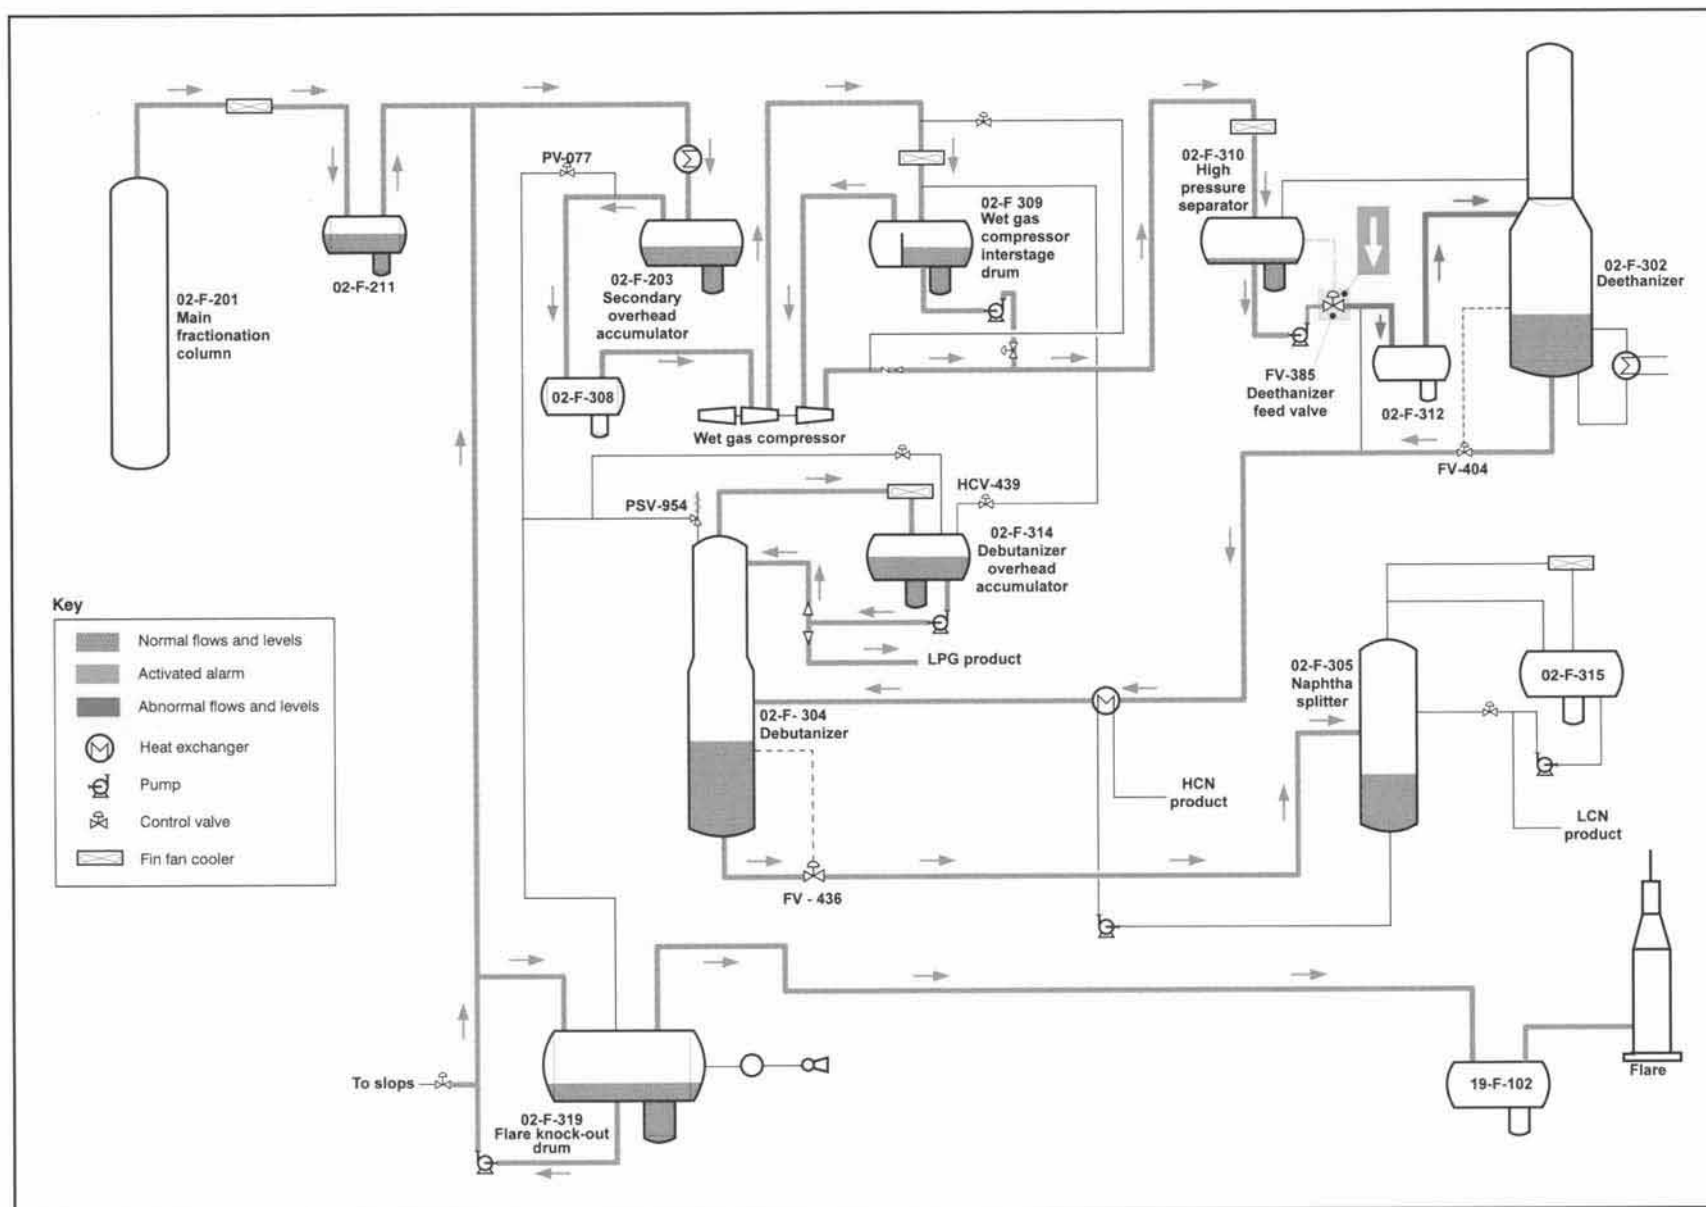
Figure 11

- 5 The flow from the deethaniser to the debutaniser via valve 02-FV-404 was about $450 \text{ m}^3\text{h}^{-1}$ at this point, consequently with no feed the deethaniser rapidly emptied and after five minutes the liquid level controller 02-LC-402 recorded zero. The level control was cascaded to the deethaniser output flow valve 02-FV-404 which closed to retain a liquid level in the deethaniser. The flow of liquid to the debutaniser was lost and as a result liquid levels in the debutaniser began to fall.

- 6 At 08.39 the debutaniser level controller cascaded to the debutaniser control which started to close the output valve (02-FV-436) to maintain the debutaniser liquid level. The liquid retained in the debutaniser by this action was material from the deethaniser which was relatively rich in low molecular weight hydrocarbon. At the higher temperatures of the debutaniser this material rapidly vaporised and at 08.46 the debutaniser pressure started to rise rapidly.

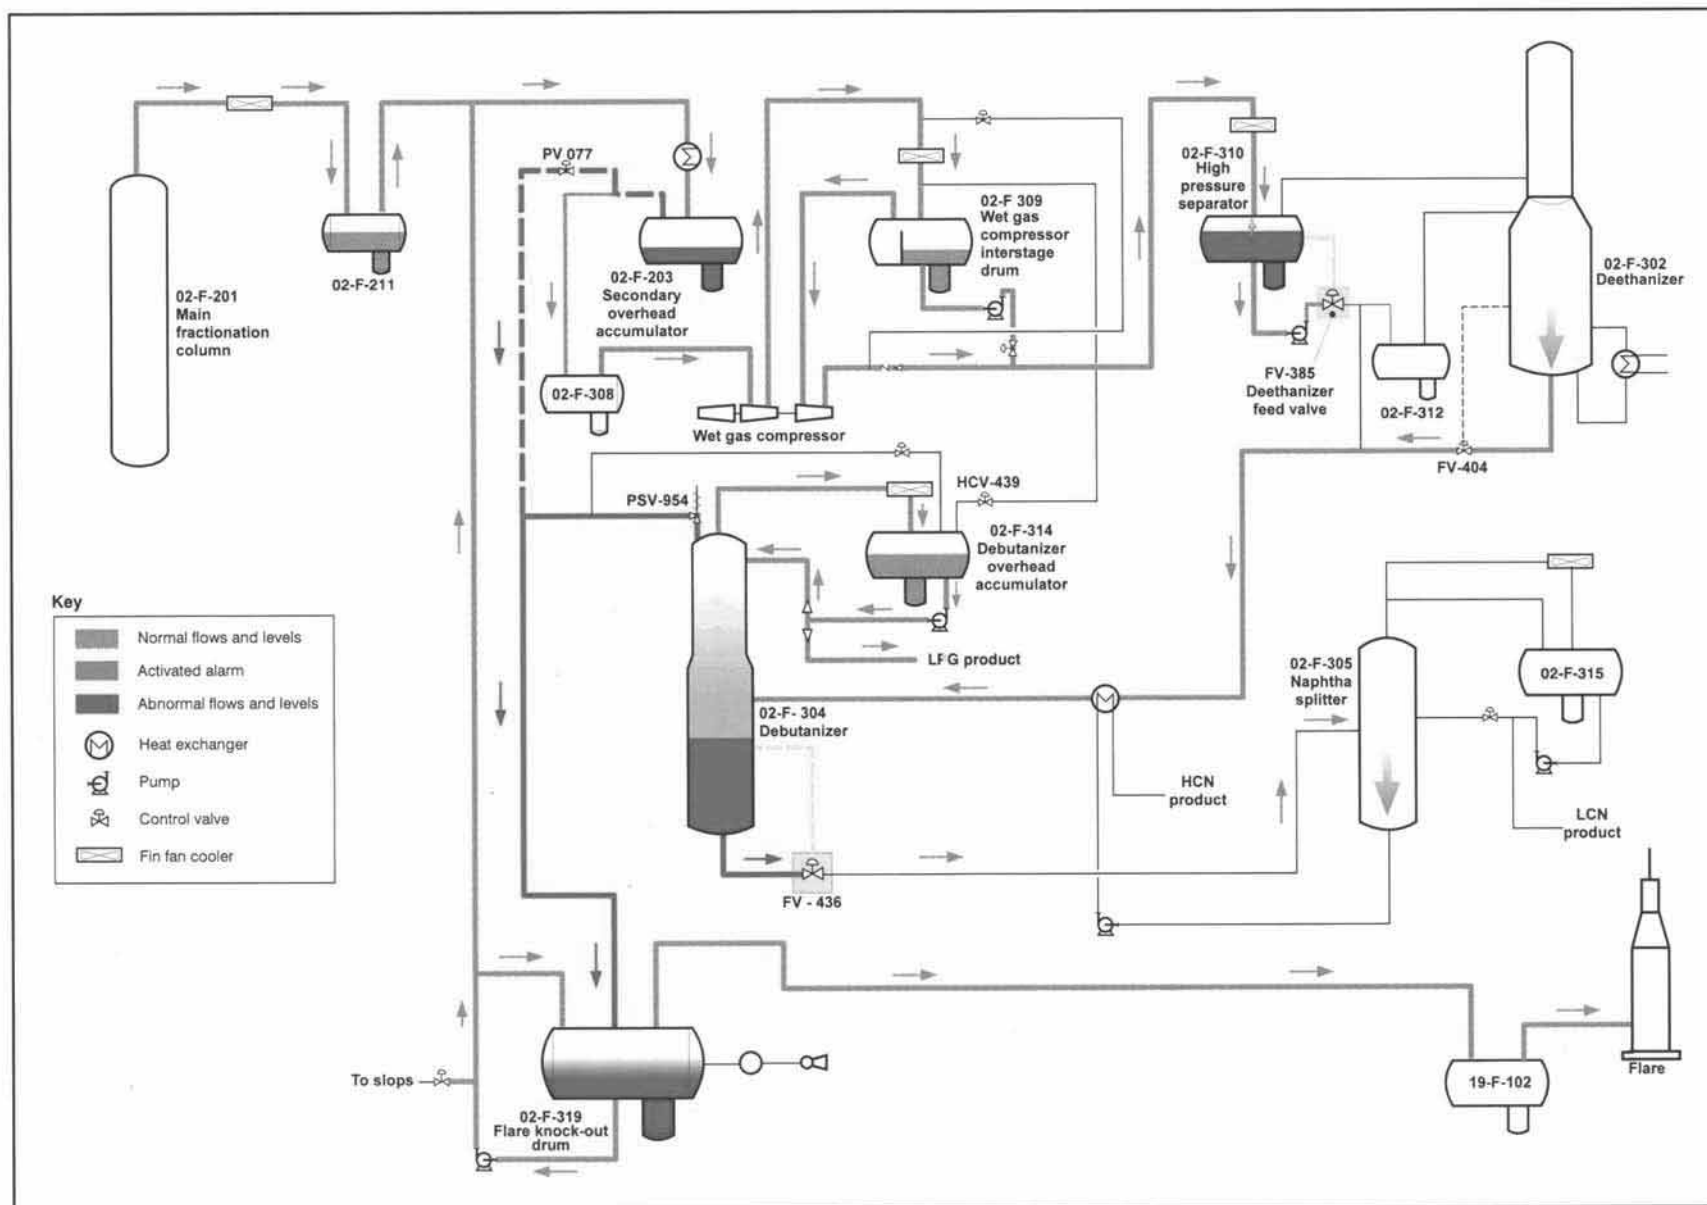
Figure 12

- 12 The pressure in the debutaniser rose because of the composition of the materials it contained. These included a high proportion of lighter fractions which would normally have been extracted by the deethaniser. On this occasion they had not been extracted because the deethaniser had emptied so quickly.

- 13 One of the four pressure relief valves (PSV954 A-D) on the debutaniser lifted (at

around 08.53) and a mixture of gas and liquid was released to the flare knock-out drum (02-F-319).

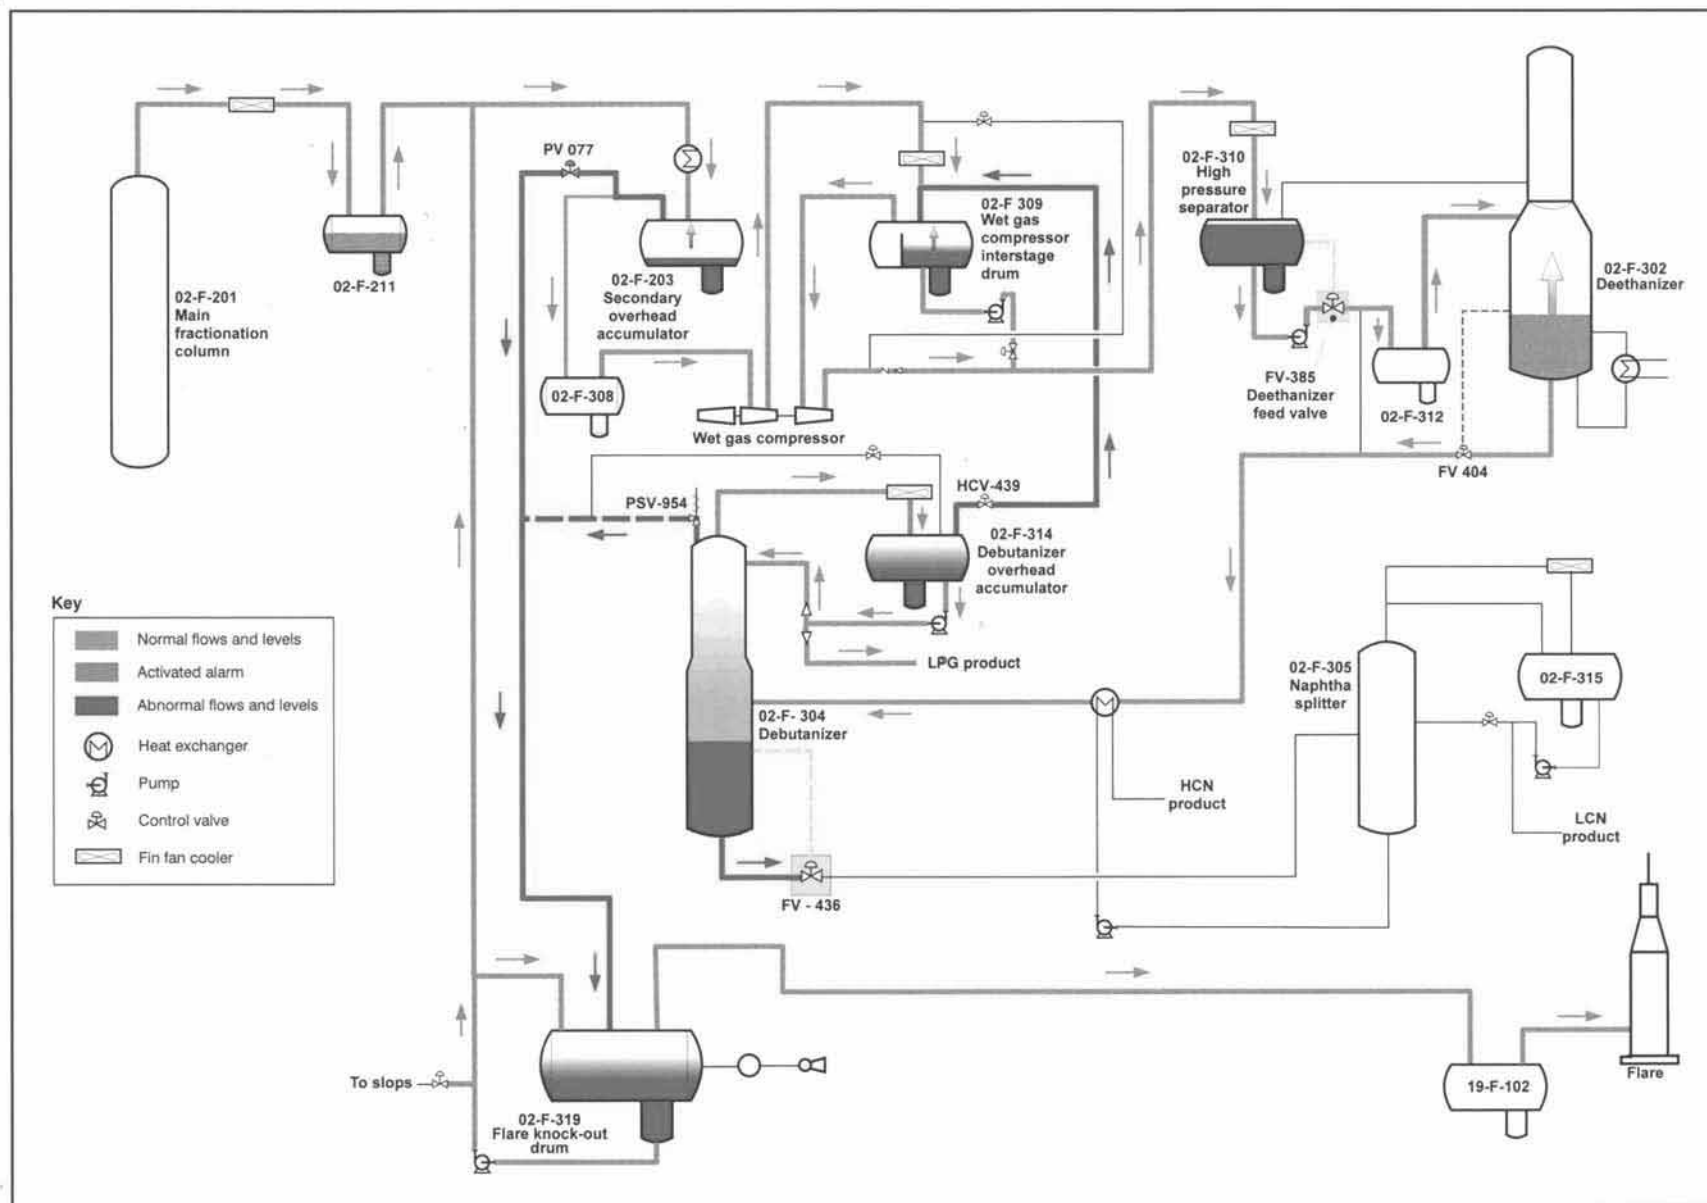
Figure 13
Approx 09.00 to 09.50

- 25 At 09.40 the hot oil flow to the debutaniser reboiler was reduced to zero, because the temperature was around 187°C, and still rising.
- 26 In the next ten minutes a series of events occurred as the debutaniser temperature and pressure continued to rise. The debutaniser liquid level gauge stayed fixed at 79% of its range. The liquid level probably exceeded this, as the column flooded. The debutaniser overhead accumulator filled with liquids and vapour due to the transfer of excess material from the debutaniser. Many of the level transmitters on the plant were of a differential pressure type. The installation design was such that following high liquid levels they could be inaccurate.

- 27 At this point the plant was in a very upset condition and the composition of the process liquids and gases was not normal. The overheating of the debutaniser column, which contained material of greater volatility than normal, therefore resulted in the rapid evolution of both liquids and gases from the top of the column into the overhead accumulator. In effect, it 'boiled over'.

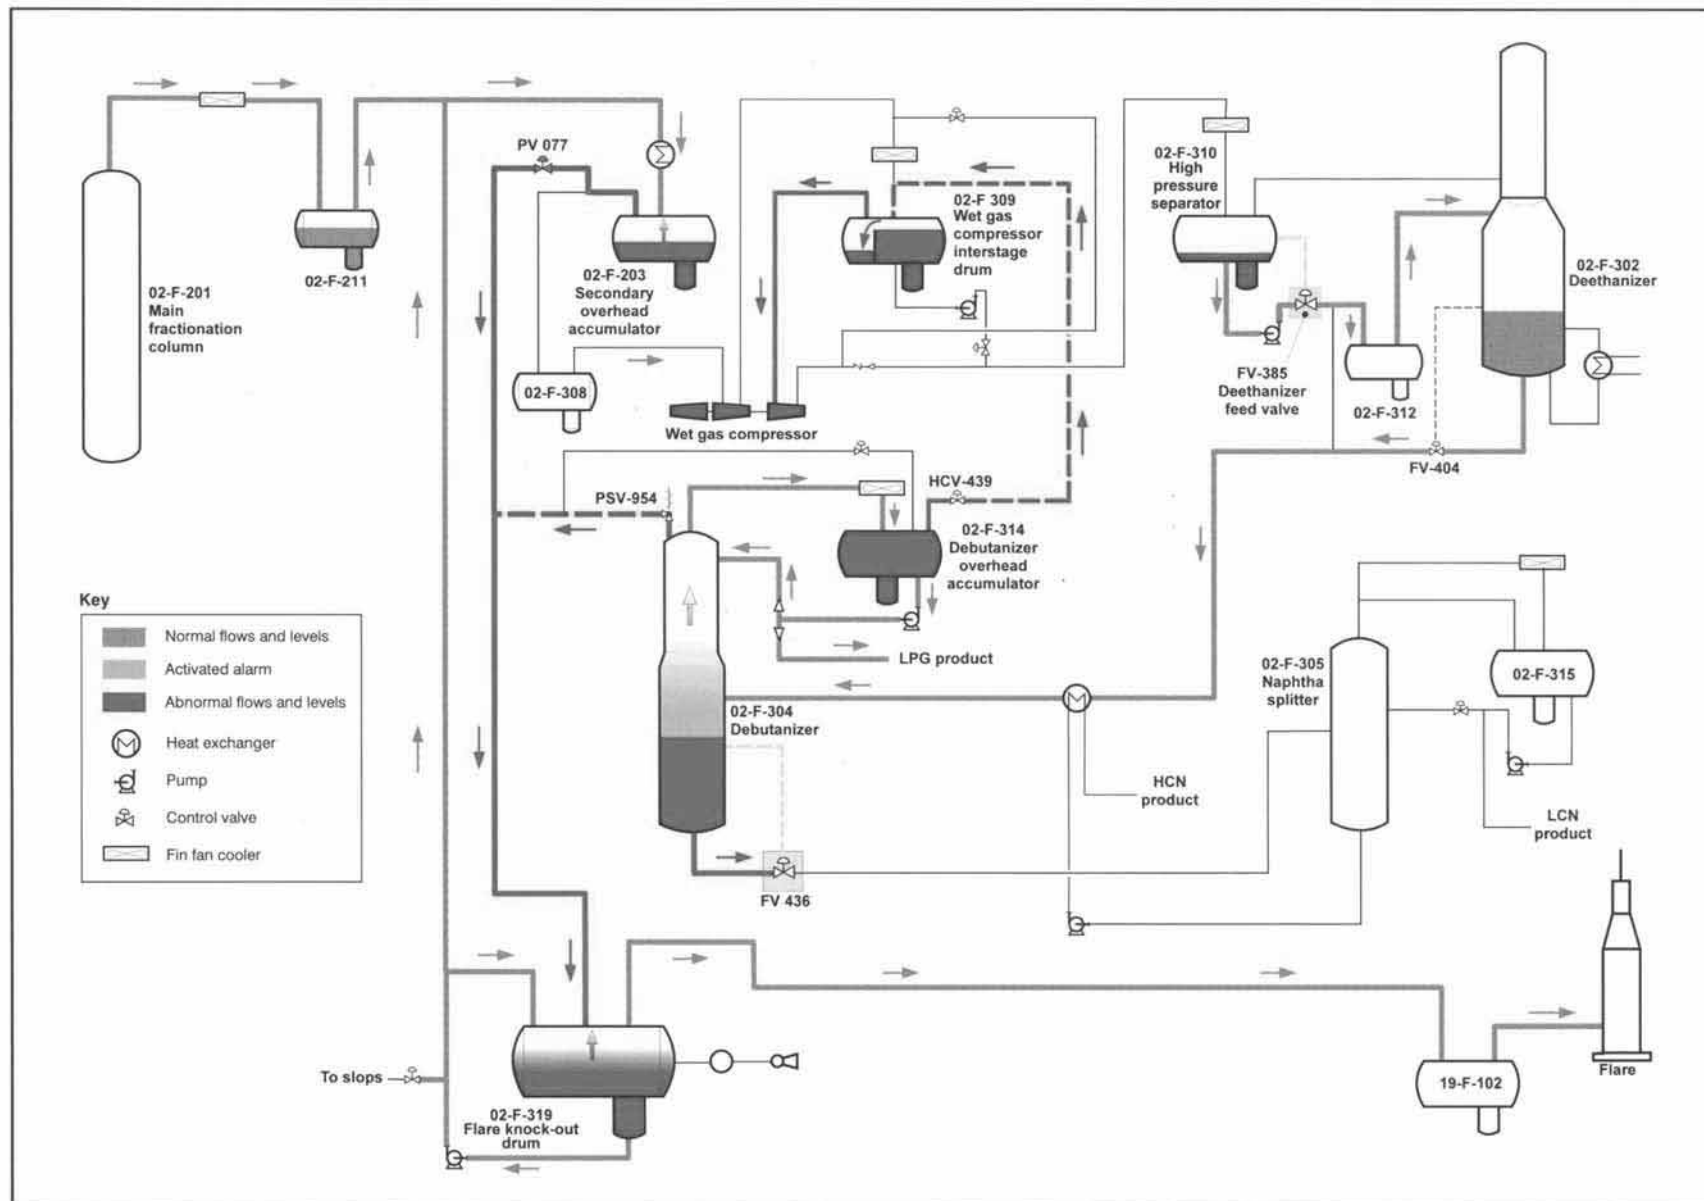
Figure 14
Approx 09.50 to 10.25

- 31 At 10.01 the debutaniser was liquid-logged and the pressure exceeded the PSV set pressure again. Pressure peaked at 12.2 barg and discharge via the debutaniser PSVs continued for 16 minutes. At 10.10 the liquid level in the knock-out drum began to rise rapidly, and rose from 61% to 93% over the next 14 minutes. This corresponded to an increase in liquid volume of 44 m^3 , and assuming a density of 630 kgm^{-3} (pentane), this represented a liquid flow rate of 33 kgsec^{-1} . This relief rate is consistent with that which could have discharged from the debutaniser PSVs.

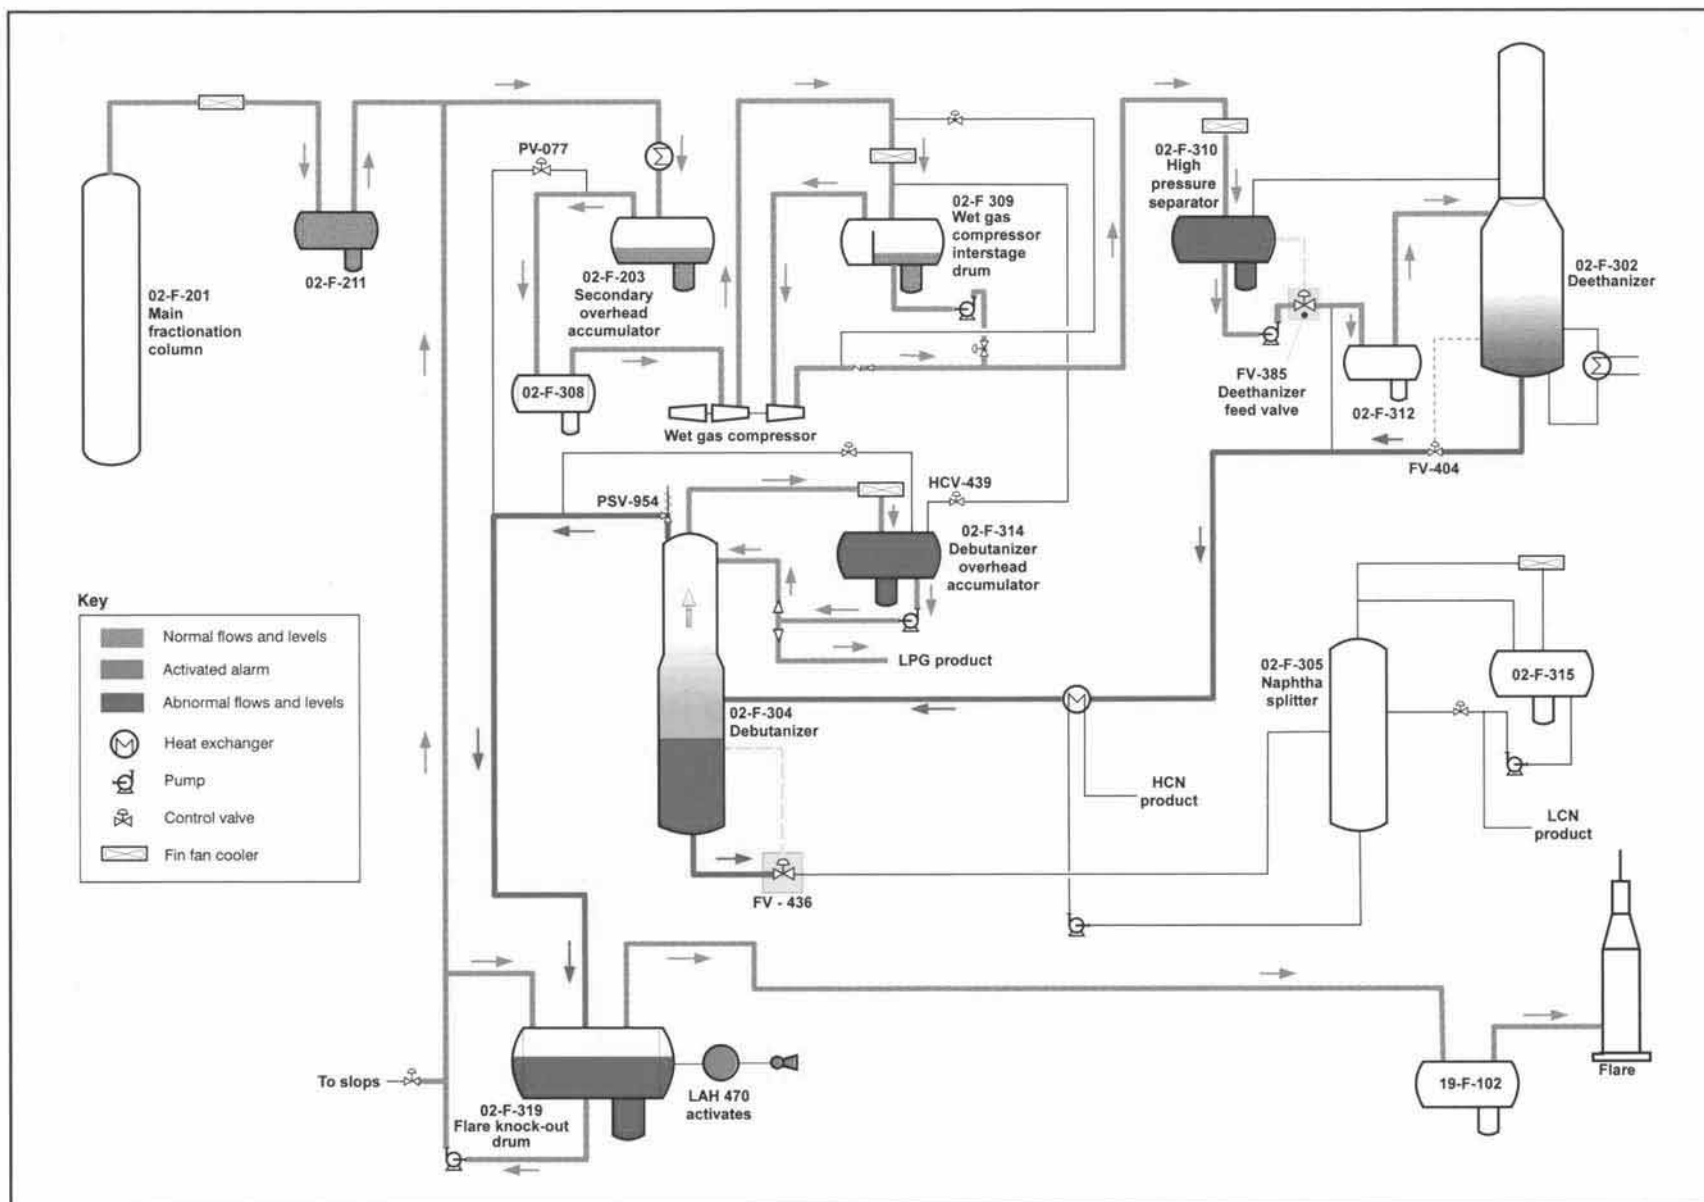
Figure 15
Approx 10.25 to 12.56

- 38 Shortly after the wet gas compressor restarted, the debutaniser pressure started to rise and by 12.46 again exceeded the relief valves' set pressure. The consequent venting to flare continued until the explosion. Assuming a density of 660 kgm^{-3} the liquid flow from the relief valves has been estimated to have peaked at 110 kgsec^{-1} at 12.40 then declined to an average of 82 kgsec^{-1} between 12.46 and 13.05, then further reduced to 64 kgsec^{-1} until 13.21.

- 39 From 12.46 the debutaniser pressure exceeded the PSV set pressure for about 40 minutes, reaching a maximum pressure of 12.8 barg. Between 12.46 and 12.56 the amount of liquid in the flare knock-out drum increased by 60.5 m³. This is equivalent to a liquid flow rate of 63.5 kgsec⁻¹ and is corresponds with the recorded rate of liquid input to the debutaniser over the same period.

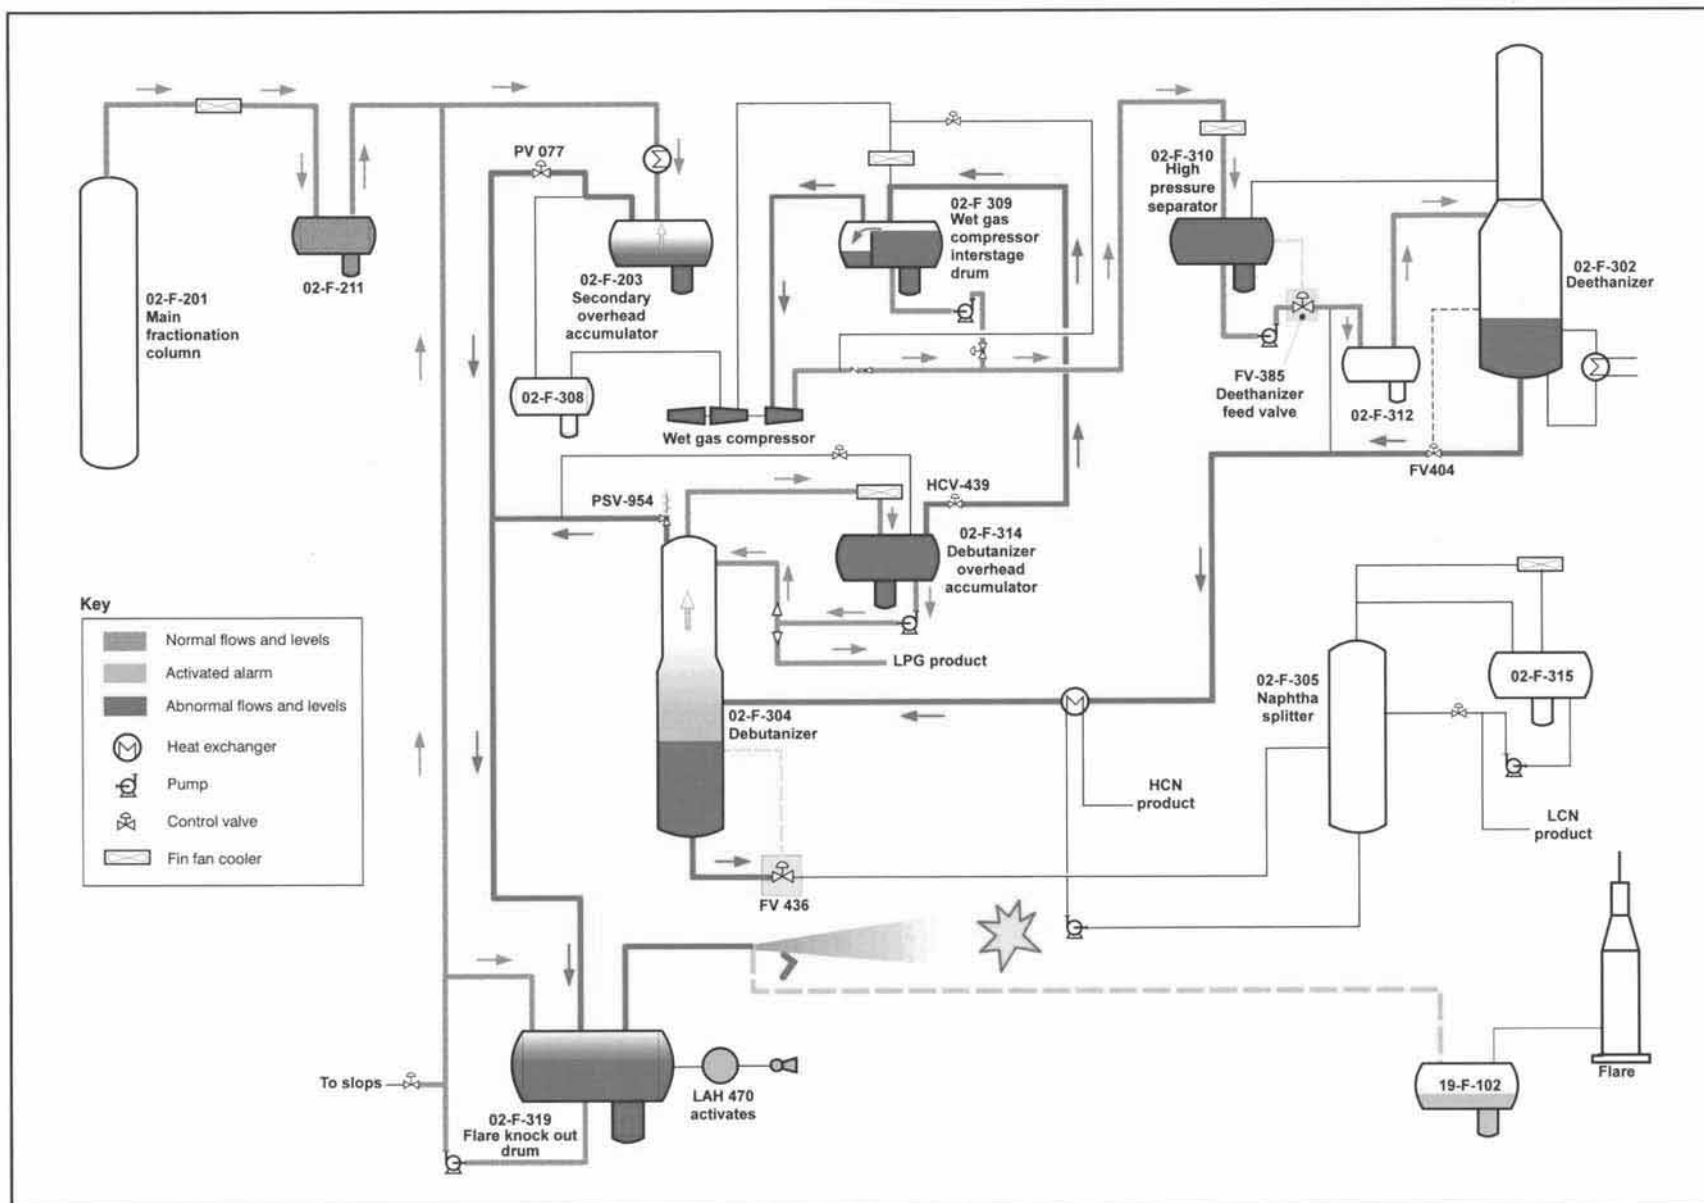
Figure 16
Approx 12.56 to 13.29

- 47 The debutaniser pressure was still not dropping so 02-HCV-439 was manually opened further to 80% and then to 100%. With hindsight, this was merely compounding the problem as the vented material was staying within the recovery section and tending to exacerbate the filling of the interstage drum.
