Ecuador: Pipeline rupture causes oil spill in rainforest

Feb 1, 2022

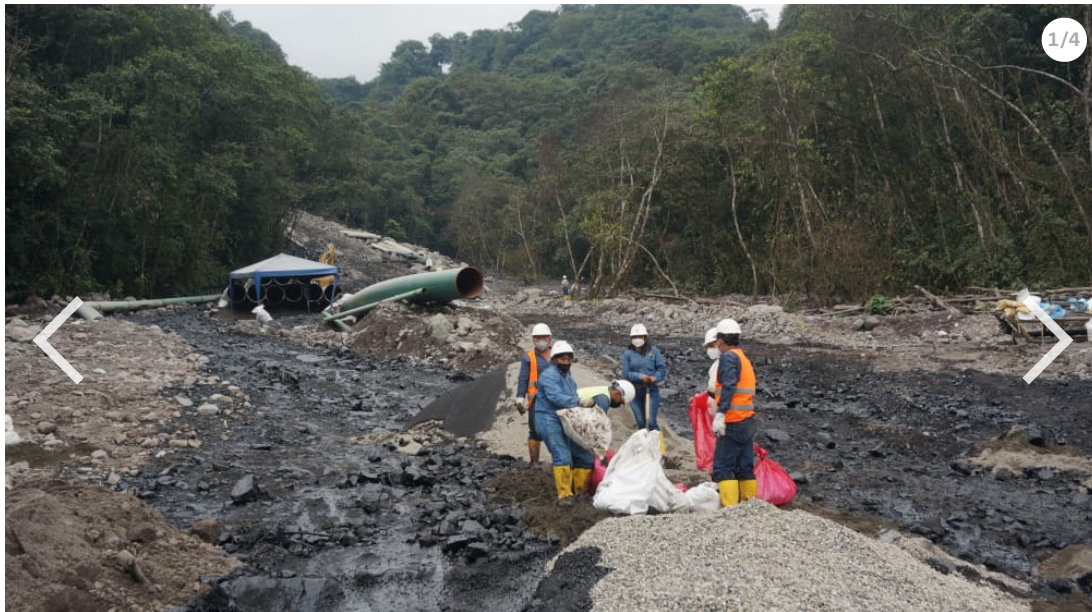
A stream of heavy oil has poured down the mountainside near Piedra Fina from the damaged OCP pipeline (Jan. 30, 2022) (© Christian Cray)

On Friday, January 28, 2022, a severe oil spill occurred in the Ecuadorian Amazon after another rupture of the OCP (Oleoducto de Crudos Pesados) heavy oil pipeline. The spill occurred on a mountain slope in the Piedra Fina sector on the edge of the Cayambe-Coca National Park.

Footage from the [Teleamazonas television network](#) shows the ruptured pipeline spouting oil into the rainforest, oil flowing between pipeline pipes down the mountainside and mixing with water from streams, which then flow into the Coca River down in the valley.

The witnesses report an unbearable stench of oil and sulfur. OCP is using excavators to create earthen basins and build dams to catch part of the spilled oil. From there, the oil is being pumped into tanker trucks for removal.

The operator OCP writes in a [press release](#) that the incident was "caused by falling rocks due to heavy rainfall". According to the statement, the company "is working at full speed to avoid any risk of oil reaching watercourses." On Saturday, moreover, "as a precautionary measure, the pumping operation of the pipeline was stopped to avoid environmental damage," OCP said in another release.
